**Cabot Oil & Gas Corporation  
Cambrian No. 1 Project  
Gainer Lee  
Wayne County, West Virginia  
Conventional Core Samples**

**Weatherford File No.: HH-77641**

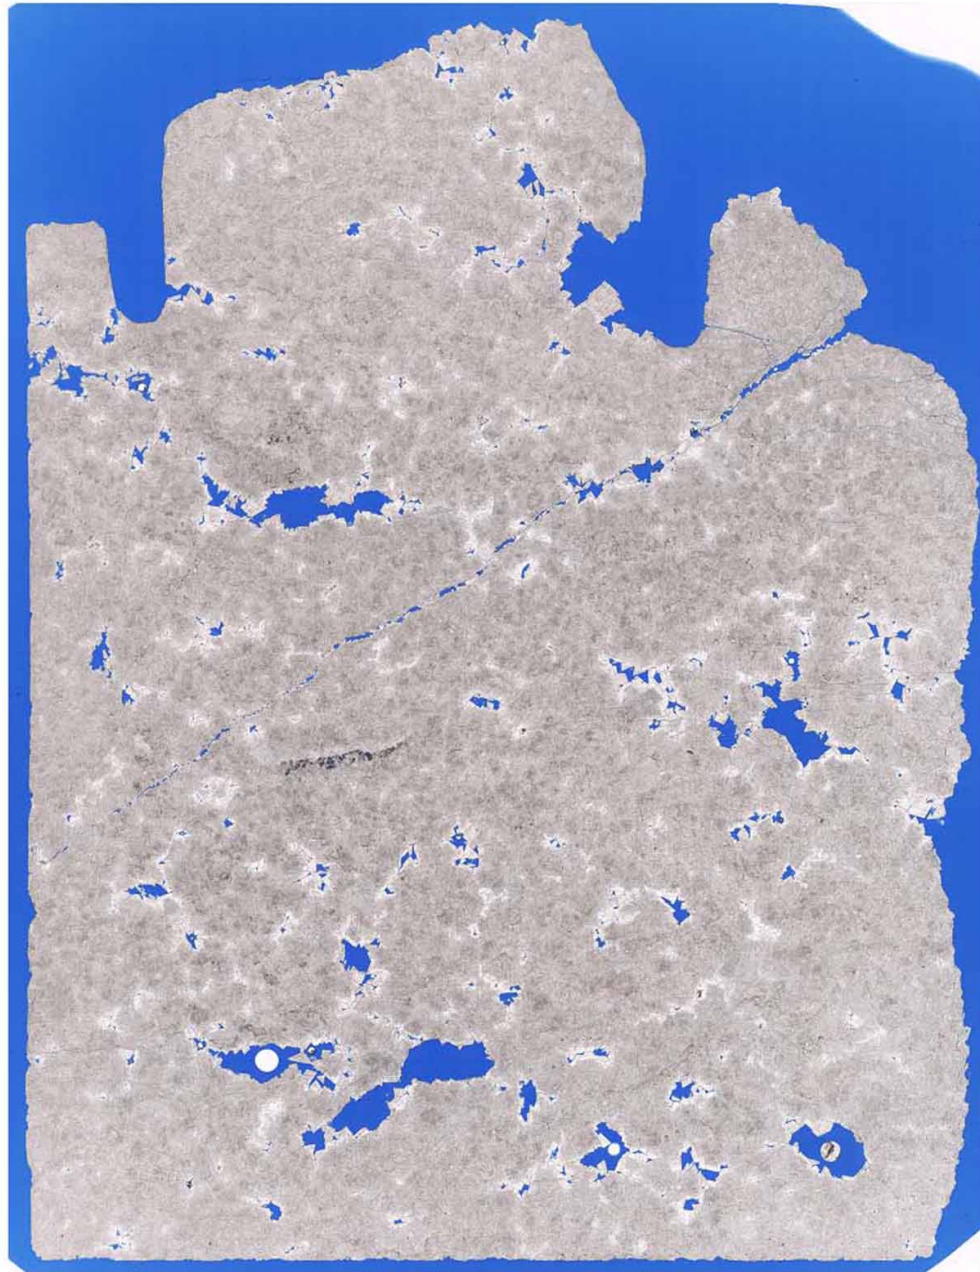
**PLATE 44A**

This static macro photo was captured from the high resolution thin section mosaic image and documents the entire thin section slide.

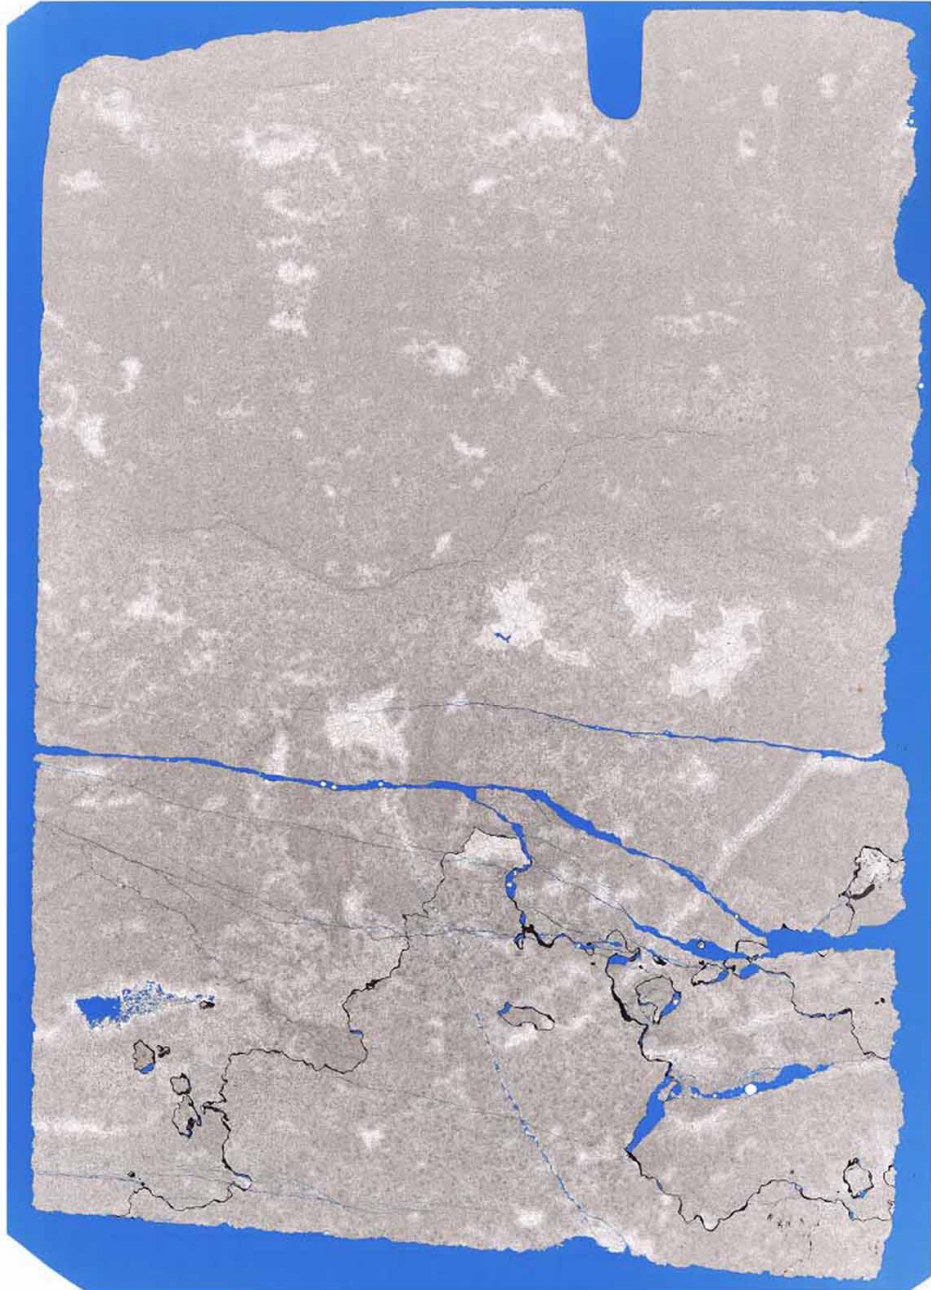
**PLATE 45A**

This static macro photo was captured from the high resolution thin section mosaic image and documents the entire thin section slide.

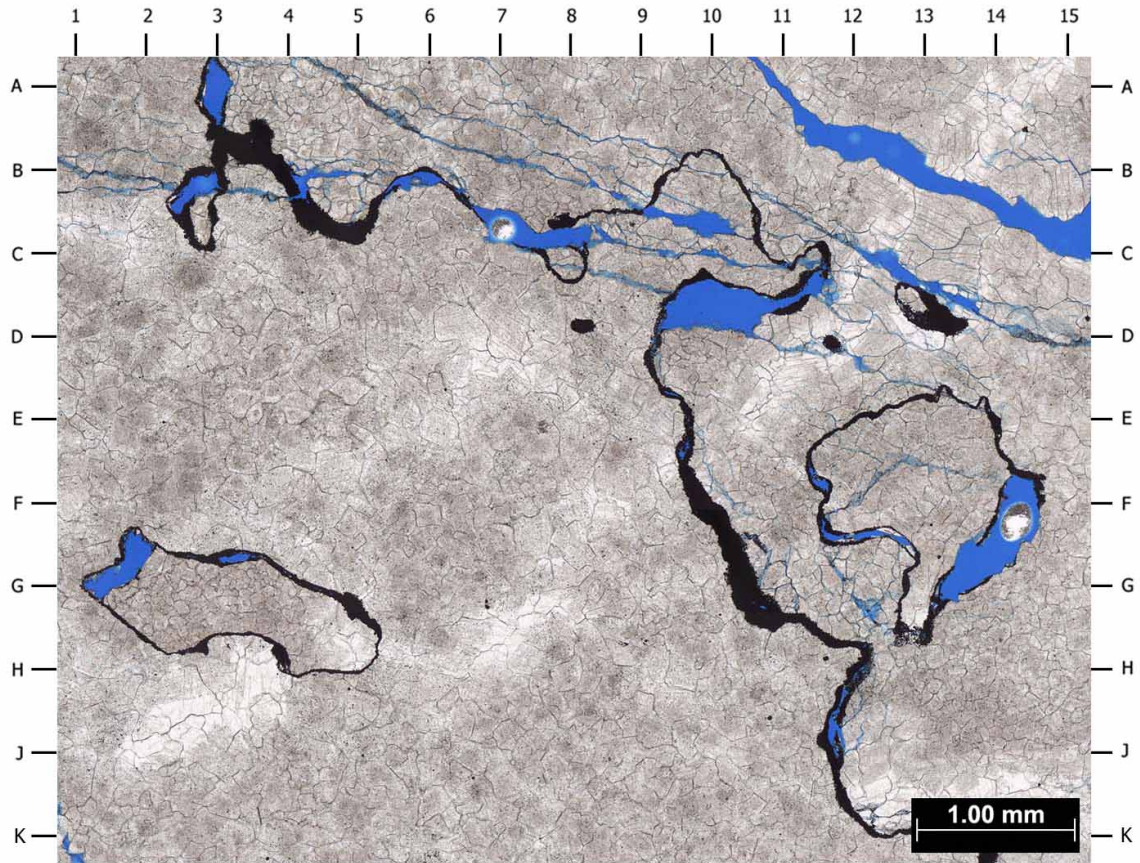
**B**

- B) This photomicrograph was taken in the bottom-right quadrant of the thin section (see Photo A). This massive, medium crystalline dolostone contains open fractures (filled with blue-dyed epoxy; A10.7-C15, B1-D15) with other fractures and vugs cemented by later stage dolomite cement (A15 to E10.5, HJ2.5). Pyritized bitumen occurs along irregular stylolites and/or fractures (black; B3 to CD11.5 to JK12.5) and also lines the walls of dolomite-cemented vugs (GH1.3-5, EG11.4-14, CD13). Preserved porosity is associated within this pyritized bitumen cement (FG1.5, A3, BC2.7, BC6, CD10, J11.8, FG13.5, FG12.5). White air bubbles are trapped within the blue epoxy at FG14 and BC7.

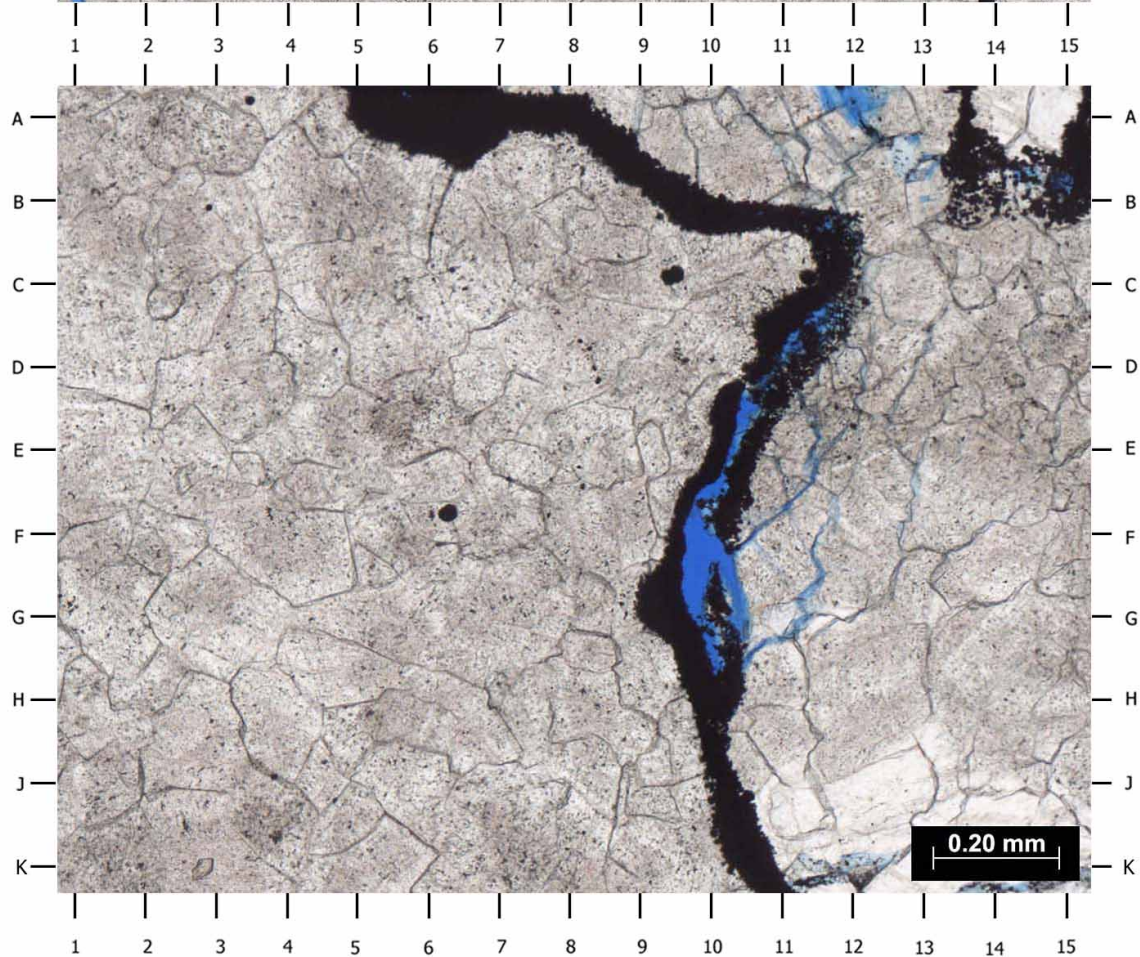
**C**

- C) This photomicrograph provides a high magnification view of the area centered near HJ11 in Photo B. Pyritized bitumen lining an irregular stylolite is visible from A5 to K11. Open fracture porosity is preserved along this stylolite at FG10 (blue epoxy). Small framboidal pyrite crystals occur at EF6 and C9.5. More pyritized bitumen occurs at AB13.5-15 lining the bottom edge of a dolomite-cemented vug. The tightly interlocking nature of the mostly anhedral dolomite crystals yields almost no visible intercrystalline porosity at this scale; therefore the only possible remaining connected pore network is expected to be associated with fracture porosity.

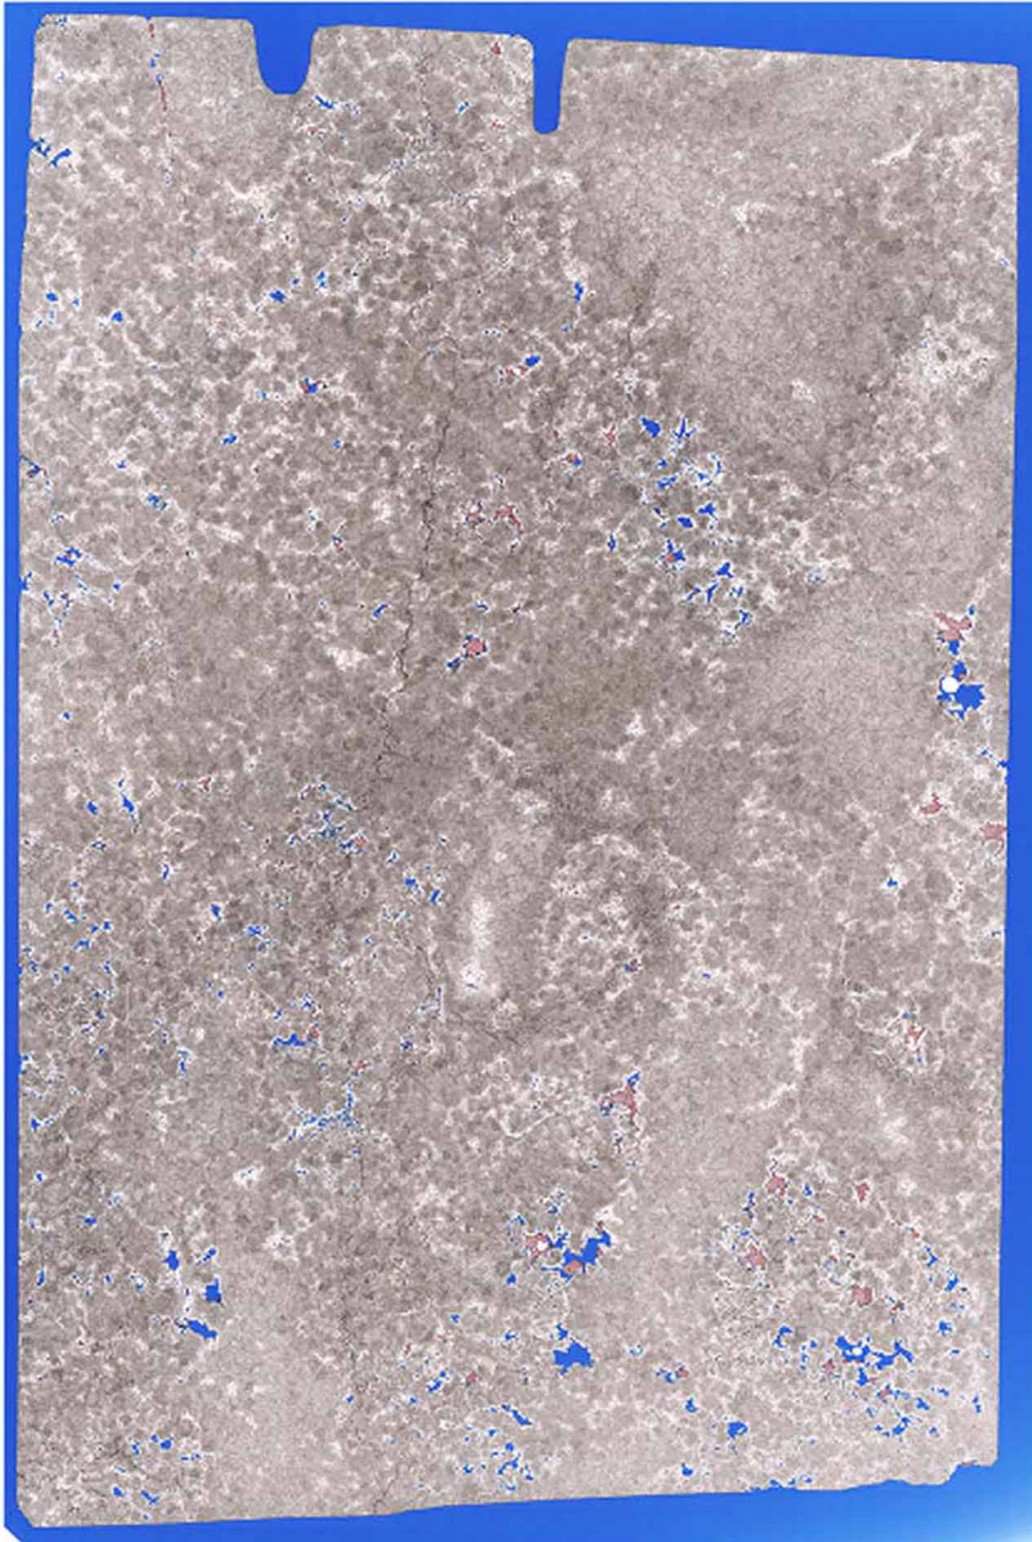
**PLATE 46A**

This static macro photo was captured from the high resolution thin section mosaic image and documents the entire thin section slide.

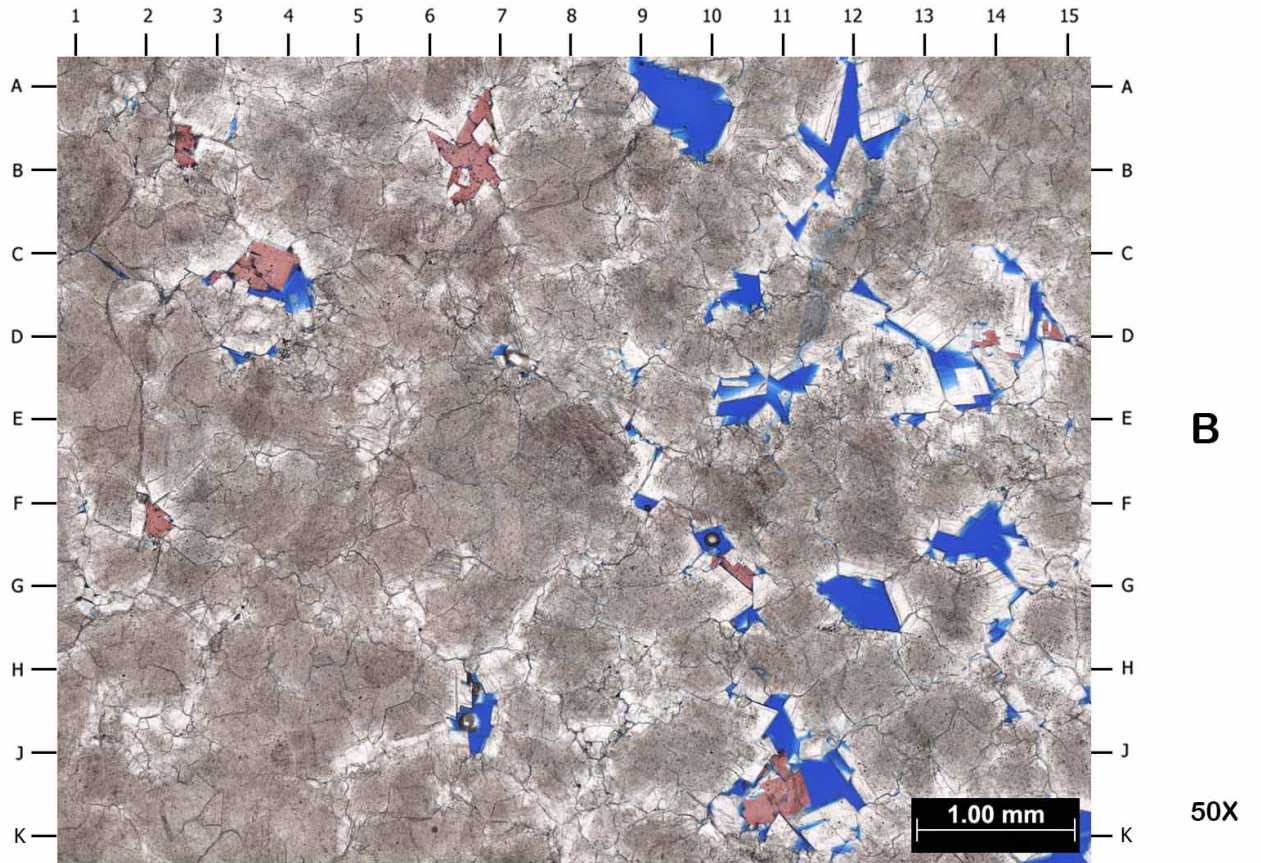
- B) Vague dark, round structures occurring throughout this medium to coarsely crystalline dolostone represent dolomitized peloids (AB5, GH15, F14.8, GH13.5, FG1.7) within the original peloidal grainstone to packstone texture (best viewed in macro Photo A). Minor to common restricted vugs to intercrystalline pores are preserved throughout the section; however the distribution is patchy and many pores may be isolated (blue epoxy; AB9.5, AB12, DE10.5, FG13.5, G12, JK11.5, HJ6.7, CD4).

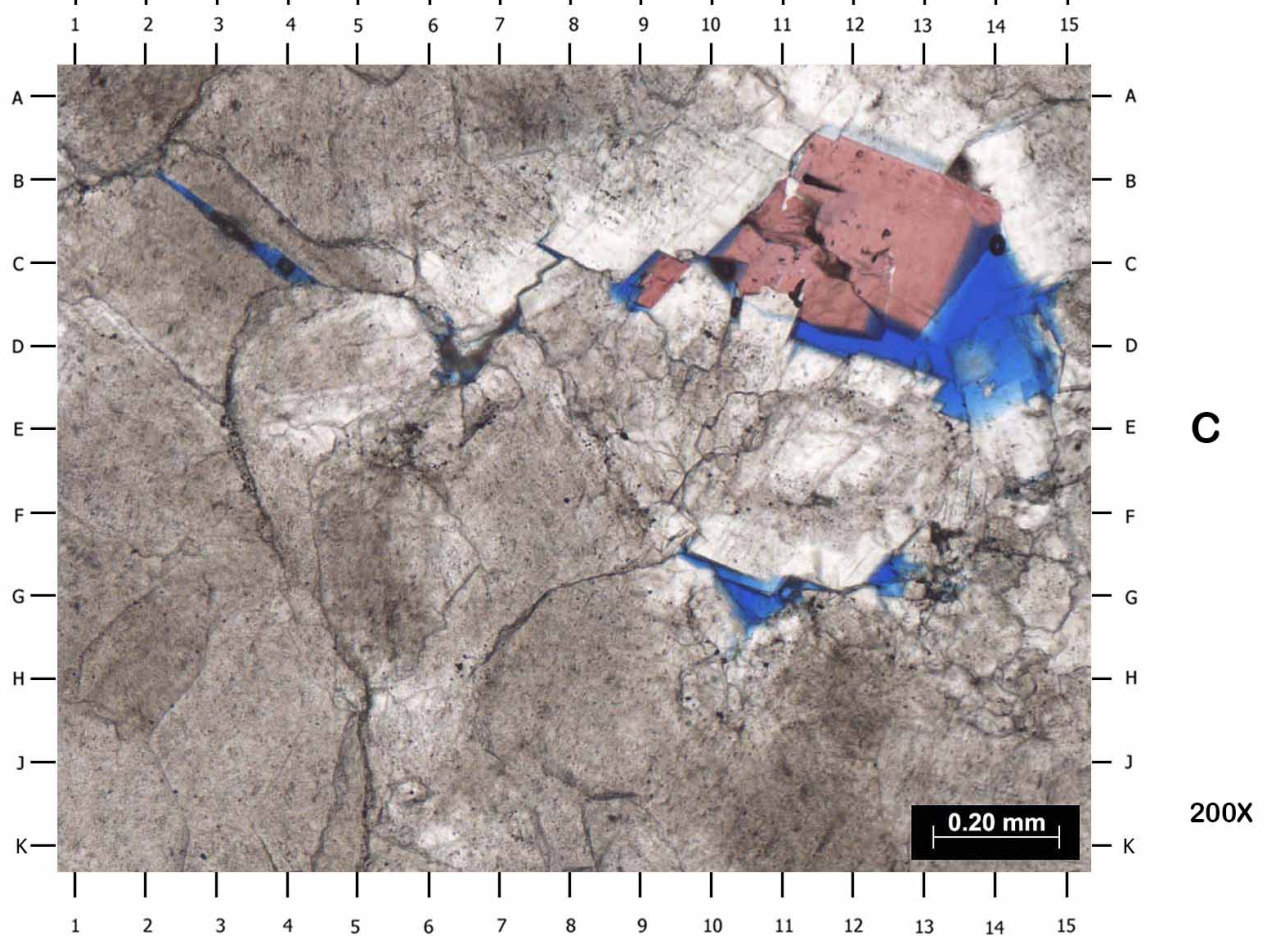
- C) This photomicrograph provides a high magnification view of the area centered near D2.5 in Photo B and documents well the various stages of replacement and cementation that have occurred within this sample. Most of the dark, dingy dolomite represents initial dolomitization of the original fabric (GK1-5, AB1-9, A14-15, J7-15, F7.5). The whiter, cleaner-looking dolomite overgrowths represent an intermediate stage of dolomite cementation (CD6.5, BC8.5, A11.5, BC14.3, DE11-13, E14, FG10-12). The most recent stage of cementation is minor sparry calcite cement precipitating within the remaining pores (stained red; C10.5-13.3, CD9.2). A trace amount of bitumen occurs imbedded within the calcite crystal at B11.5 (black).

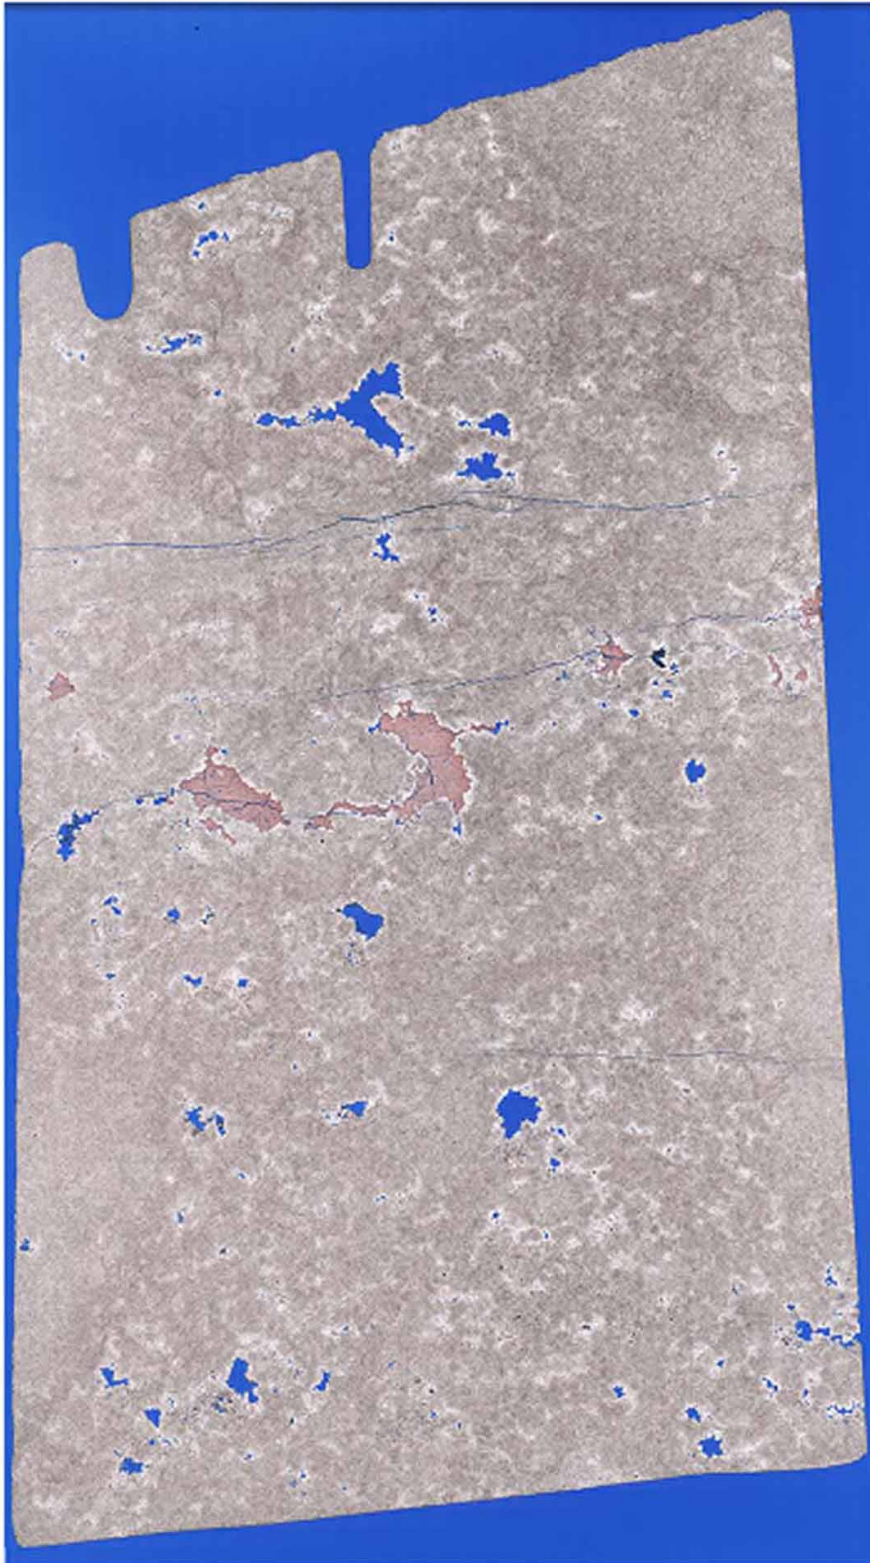
**PLATE 47A**

This static macro photo was captured from the high resolution thin section mosaic image and documents the entire thin section slide.

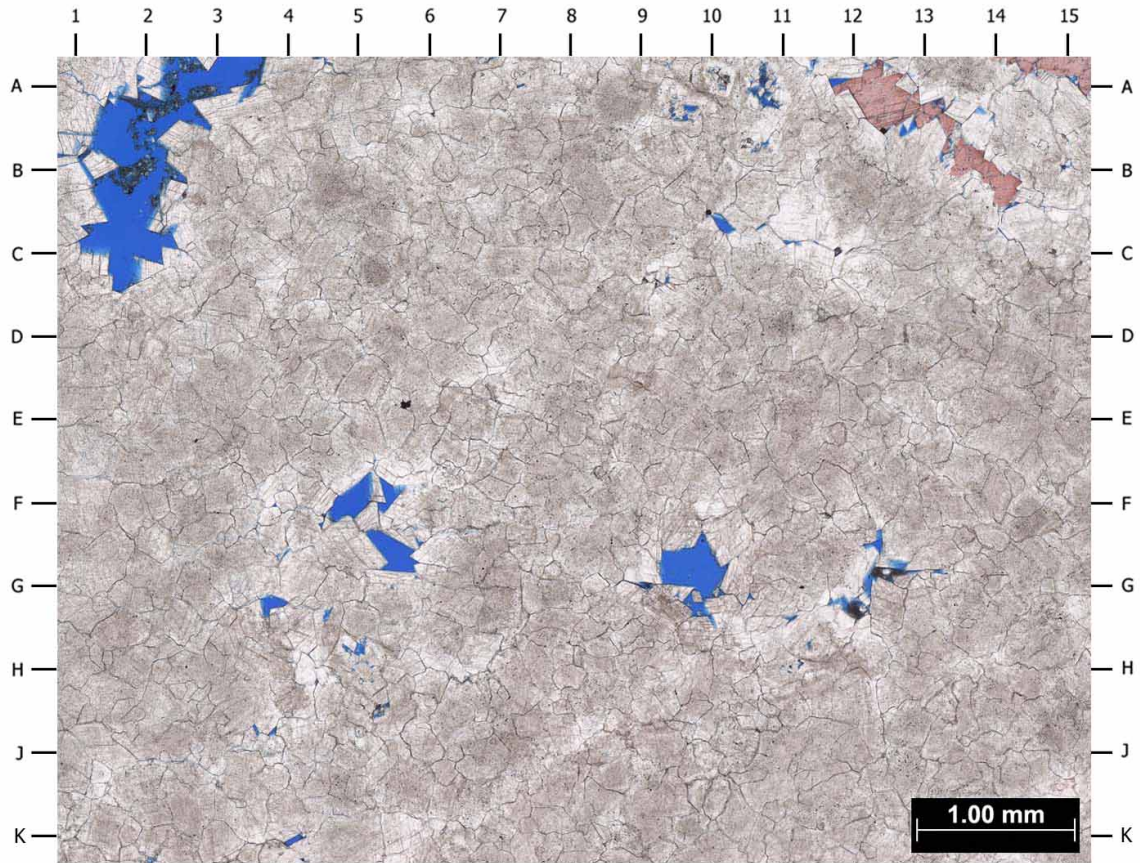
**B**

- B) This medium to coarsely crystalline dolostone exhibits a dolomitized, peloidal grainstone to packstone texture. Minor large vugs (filled with blue epoxy; BC2, F5, G9.5, GH4) are restricted by euhedral dolomite overgrowths (BC2.5, AB2.4, C11) and/or occluded by late stage sparry calcite cement (stained red; AB12.4-B14, A15). Vague round peloidal structures occur throughout and are remnants of the original fabric (CD5.2, FG14.4, AB8.9).
- C) This photomicrograph provides a high magnification view of the area centered near GH2.8 in Photo B. This photo documents the tightly interlocking nature of the subhedral to anhedral dolomite crystals that dominate this sample. Small intercrystalline pores are likely isolated from other nearby pores (AB13.5, DE13, K11.9).

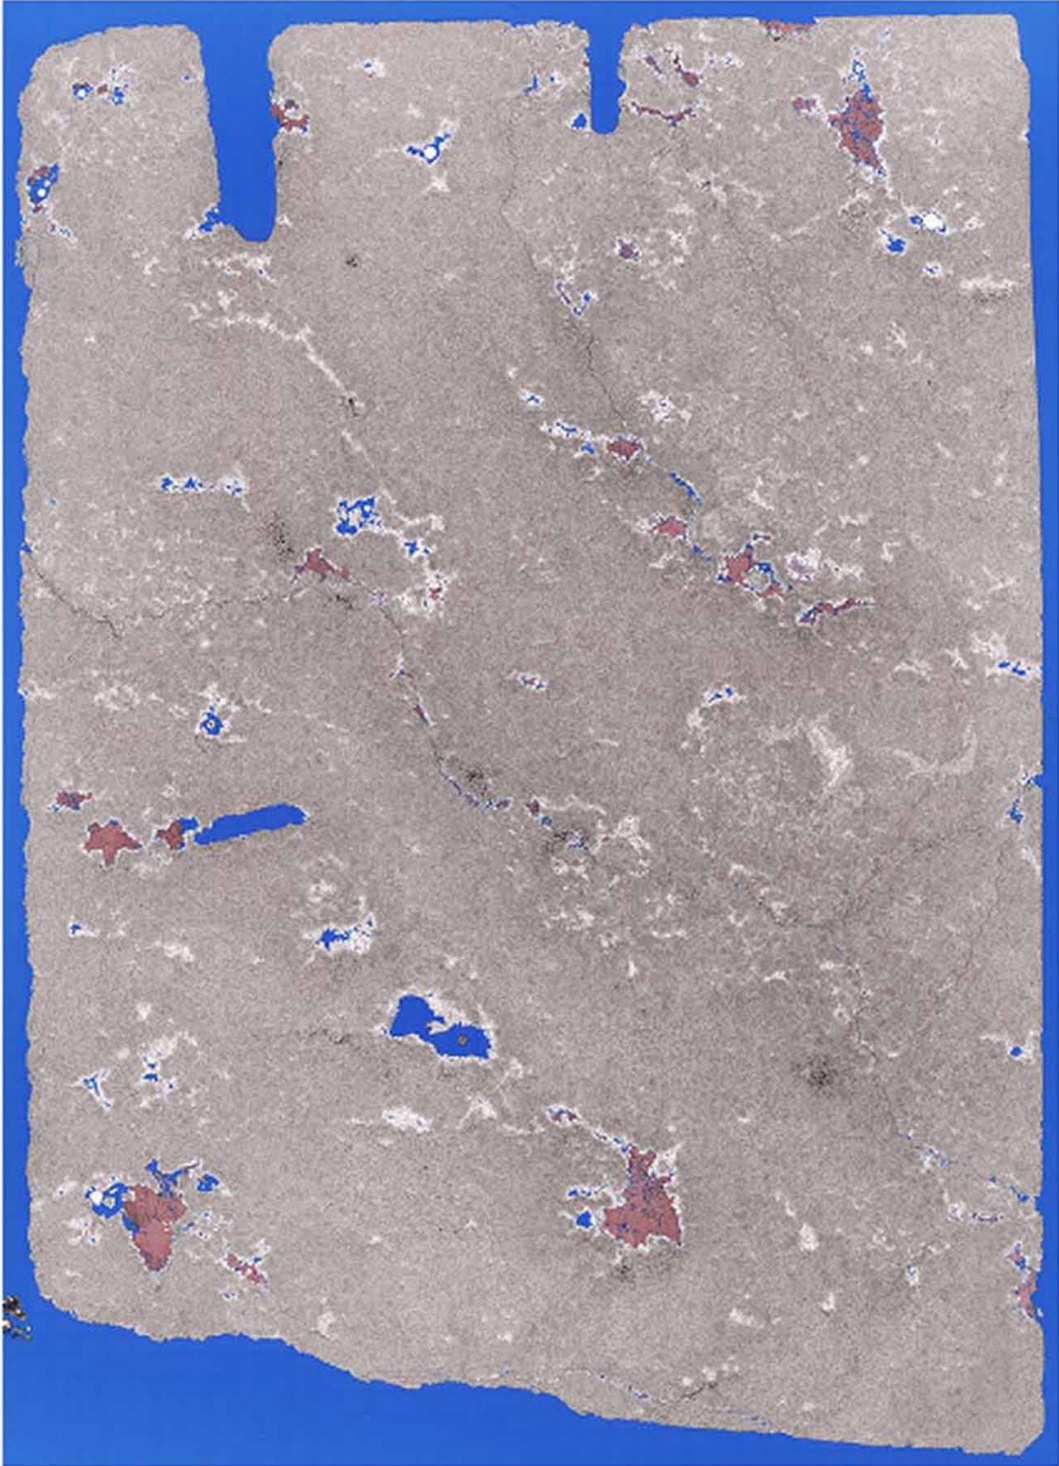
**PLATE 48A**

This static macro photo was captured from the high resolution thin section mosaic image and documents the entire thin section slide.

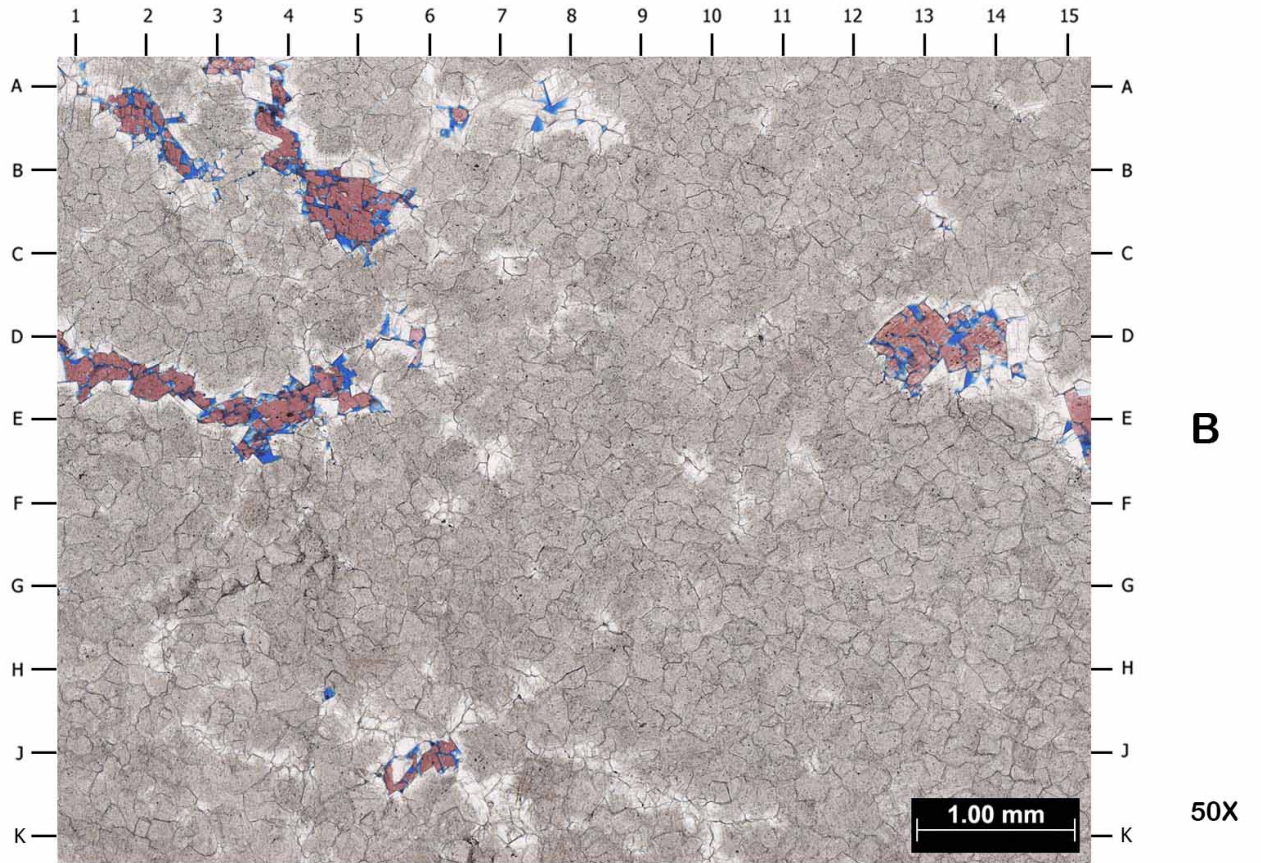
- B) This medium crystalline dolostone is comprised predominantly of subhedral to anhedral, tightly interlocking dolomite crystals. Euhedral dolomite crystals are associated with dolomite overgrowths development along the edges of partially restricted vugs (blue-dyed epoxy; AB7.8, D5.4). Late stage sparry calcite cement partially occluded the remaining secondary porosity within vugs (stained red; AB2, BC5, D13, DE1-5, J6). This photo illustrates the area near the top right of the thin section, just to the right of the smaller notch in the macro Photo A.

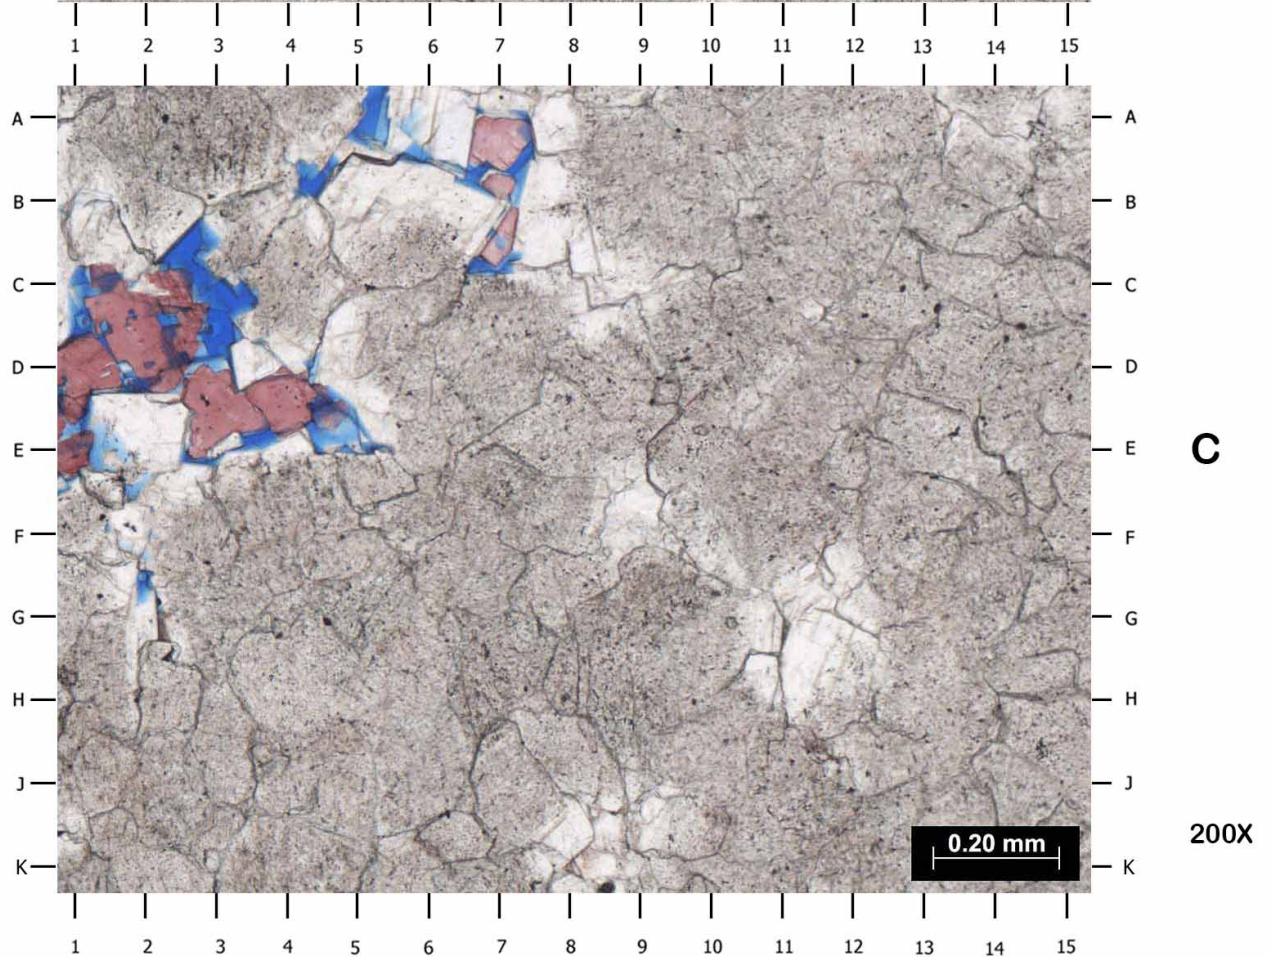
- C) This photomicrograph provides a high magnification view of the area centered near E6 in Photo B. A small partially cemented vug is visible in the top left; the presence of blue-dyed epoxy indicates open pores (C3, C1.2, E4.8, AB4.4, A5.3, AB7.4, BC6.9). The darker dirty-looking dolomite represents early stage dolomite replacement of the original fabric and is very tight with almost no intercrystalline porosity observed (DE6-15, AB9-13, GK3-7). Intermediate stage dolomite overgrowths appear white and restrict secondary vugs (DE2, D4.6, B5.5, GH11.3, JK8). More recent sparry calcite cementation is incomplete, leaving open porosity within and around the edges of the calcite crystals (stained red; CD2, DE3).

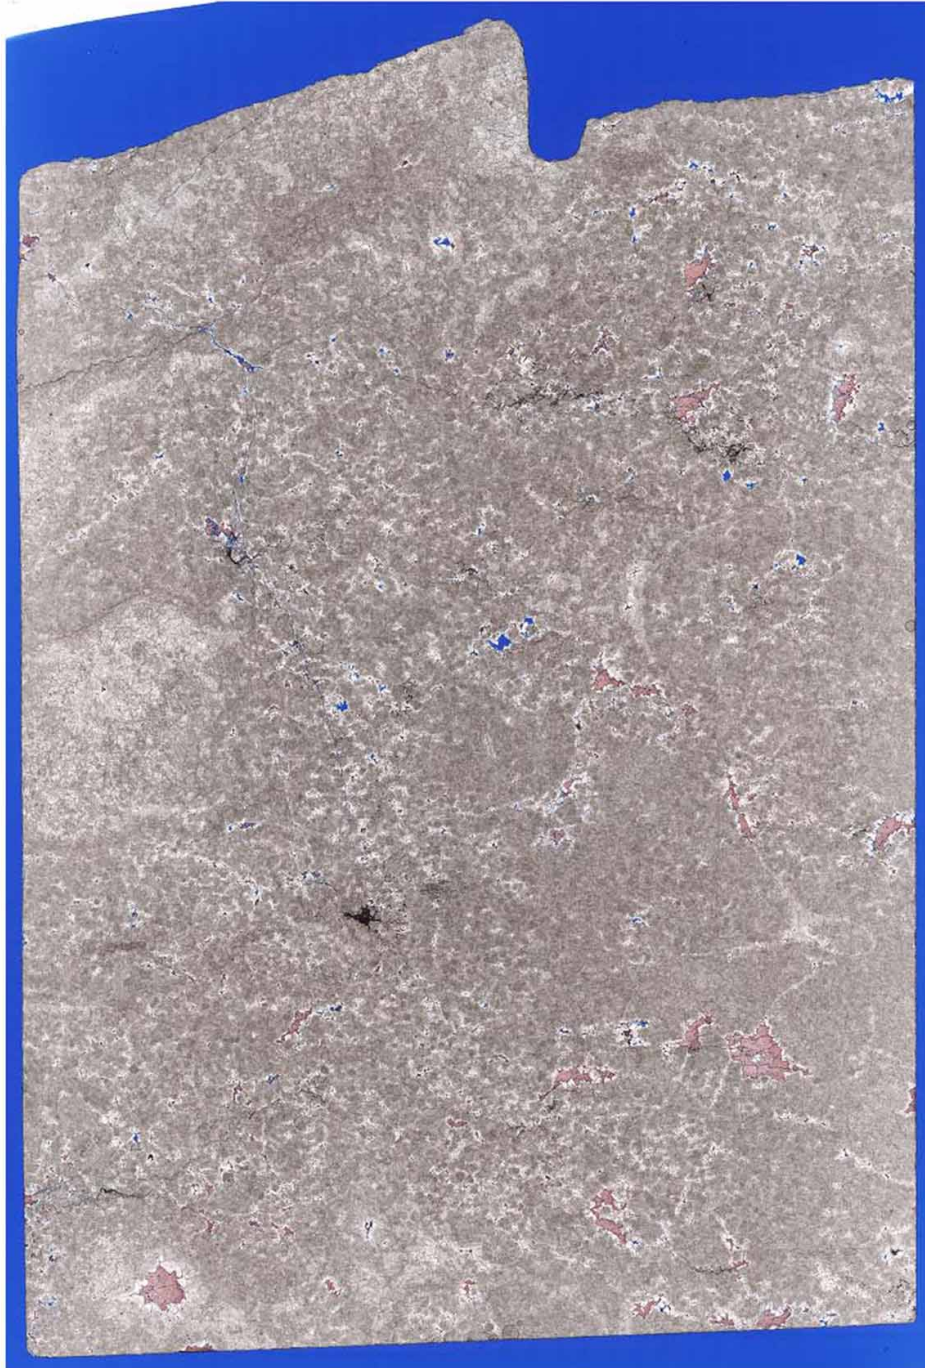
**PLATE 49A**

This static macro photo was captured from the high resolution thin section mosaic image and documents the entire thin section slide.

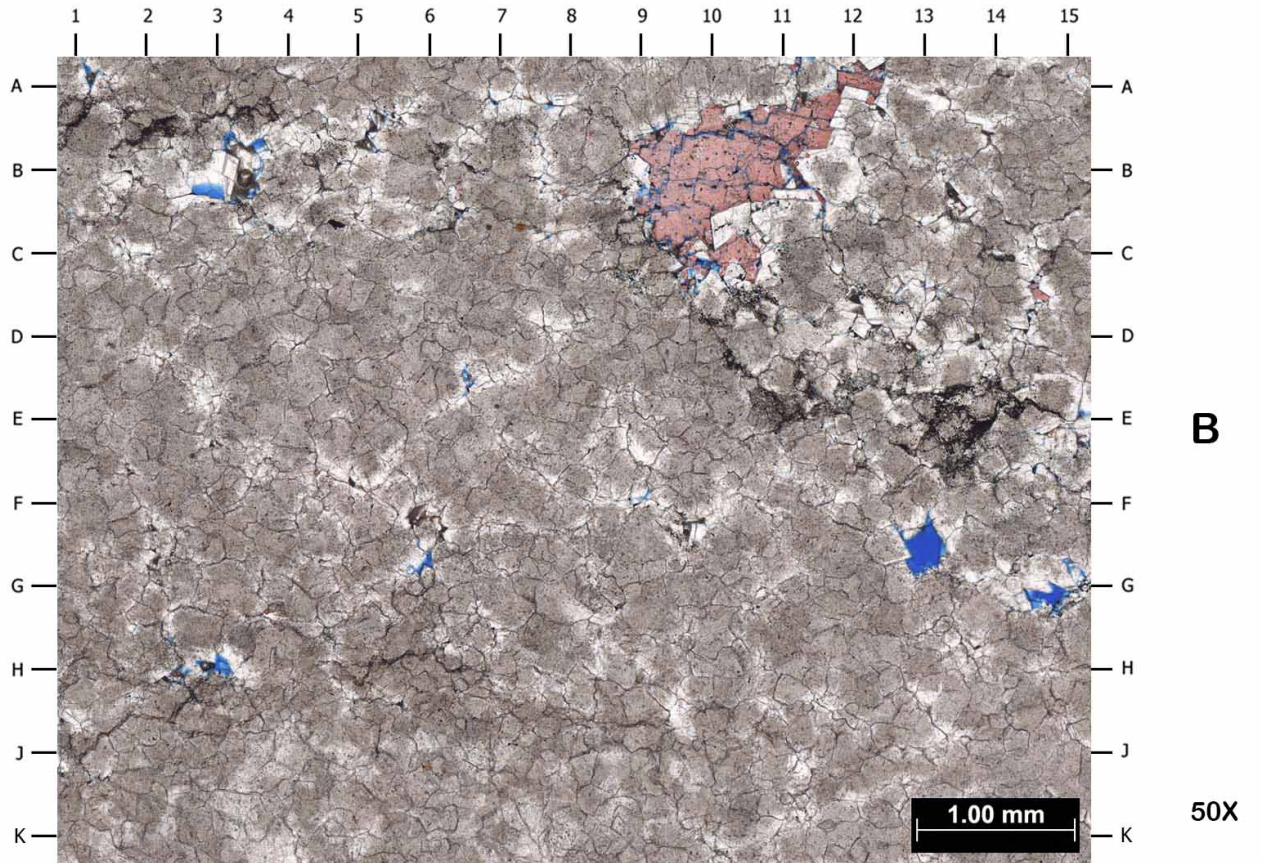
- B) This completely dolomitized sample consists predominantly of medium crystalline, subhedral to anhedral dolomite crystals (CD1-7, JK1-15). Euhedral dolomite overgrowths (whiter; B3, B12, D12) occur along minor secondary intercrystalline pores and vugs (blue epoxy; FG13, H3, BC3, G14.7). Sparry calcite cement occludes most of the larger vugs (stained red; B10). The original texture of this sample (before dolomitization) is interpreted to be bioturbated, patchy, peloidal grainstone to packstone.

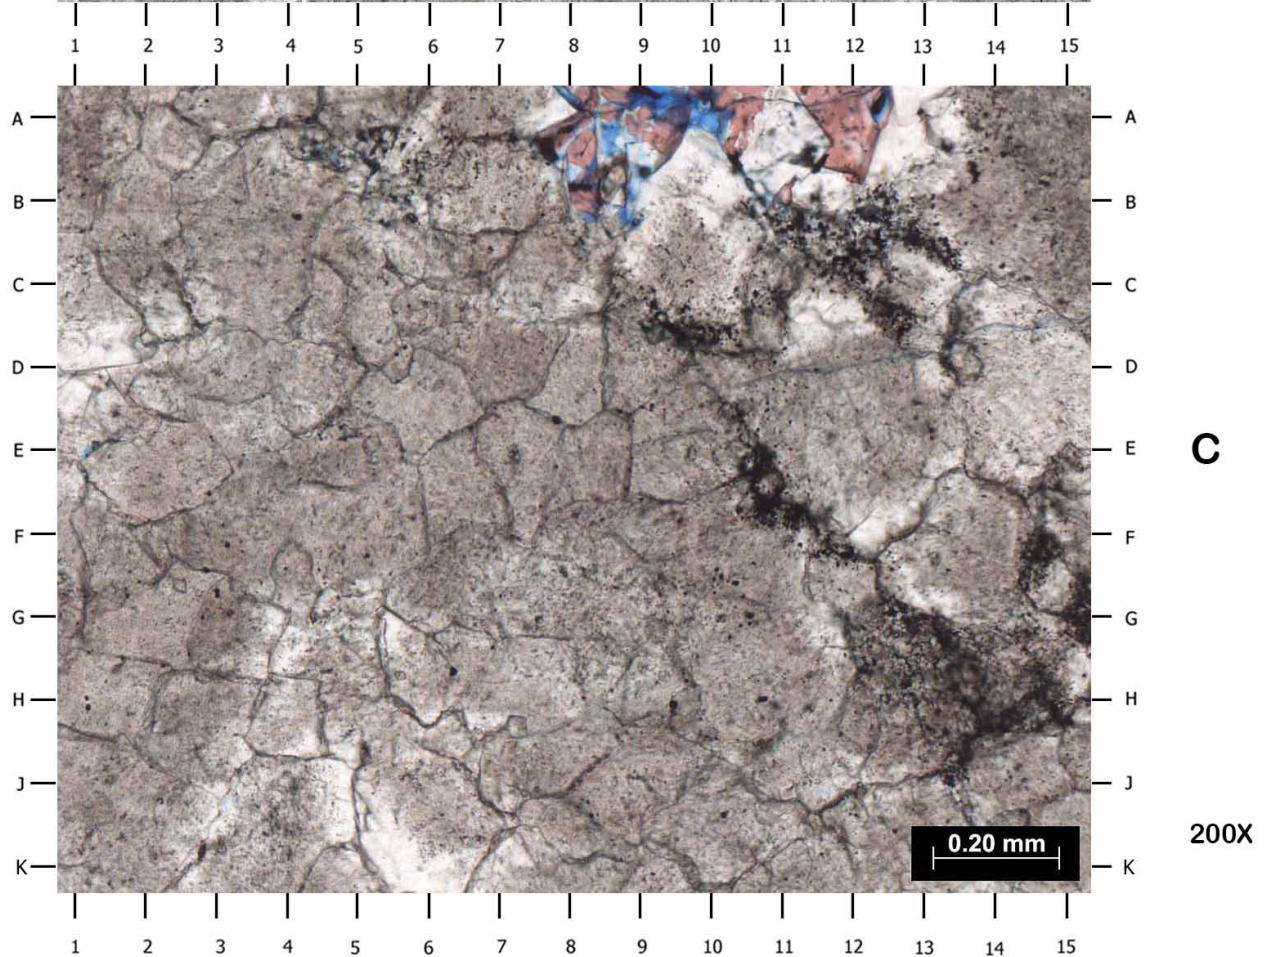
- C) This photomicrograph provides a high magnification view of the area centered near D9.5 in Photo B. The majority dolomite matrix consists of tightly interconnected crystals with almost no visible intercrystalline porosity. Although most of the hairline microfractures presently connecting restricted vugs appear to be completely closed and non-viable passageways for fluid exchange, the presence of microcrystalline pyrite (black; AB5, CD9.5, EF10.5, G13-J13.5, G15, BC13) precipitating along some of these microfractures and intercrystalline joints provides evidence that (at least in the past) some of these microfractures were viable avenues for fluids and ion exchange between neighboring vugs. The presence of sparry calcite (stained red; AB12, A8.5) within these vugs provides further evidence that these vugs were once interconnected by a local microfracture network that allowed for fluid exchange between vugs.

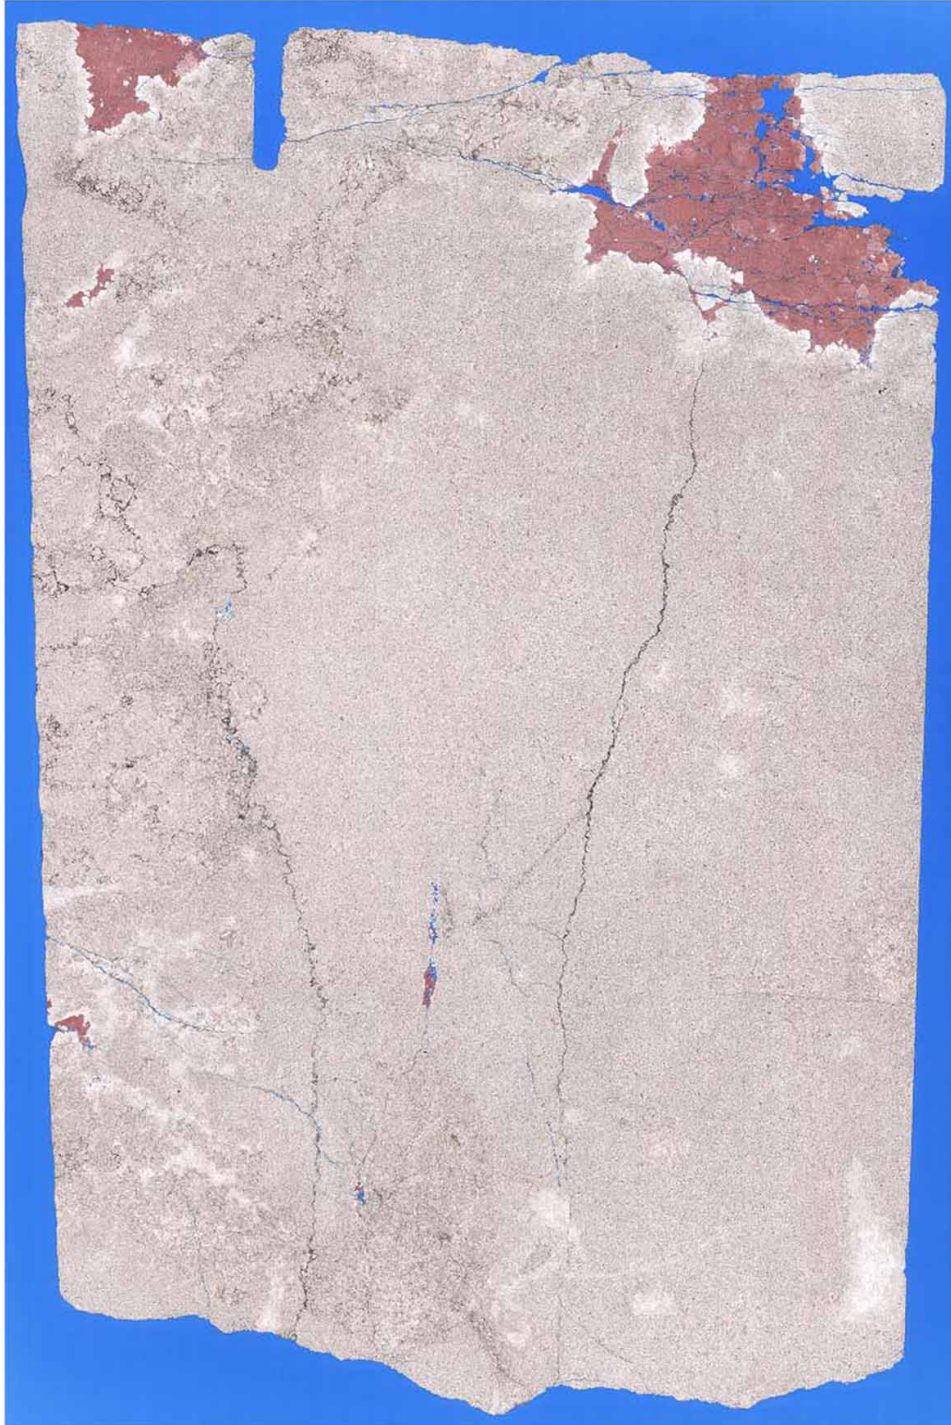
**PLATE 50A**

This static macro photo was captured from the high resolution thin section mosaic image and documents the entire thin section slide.

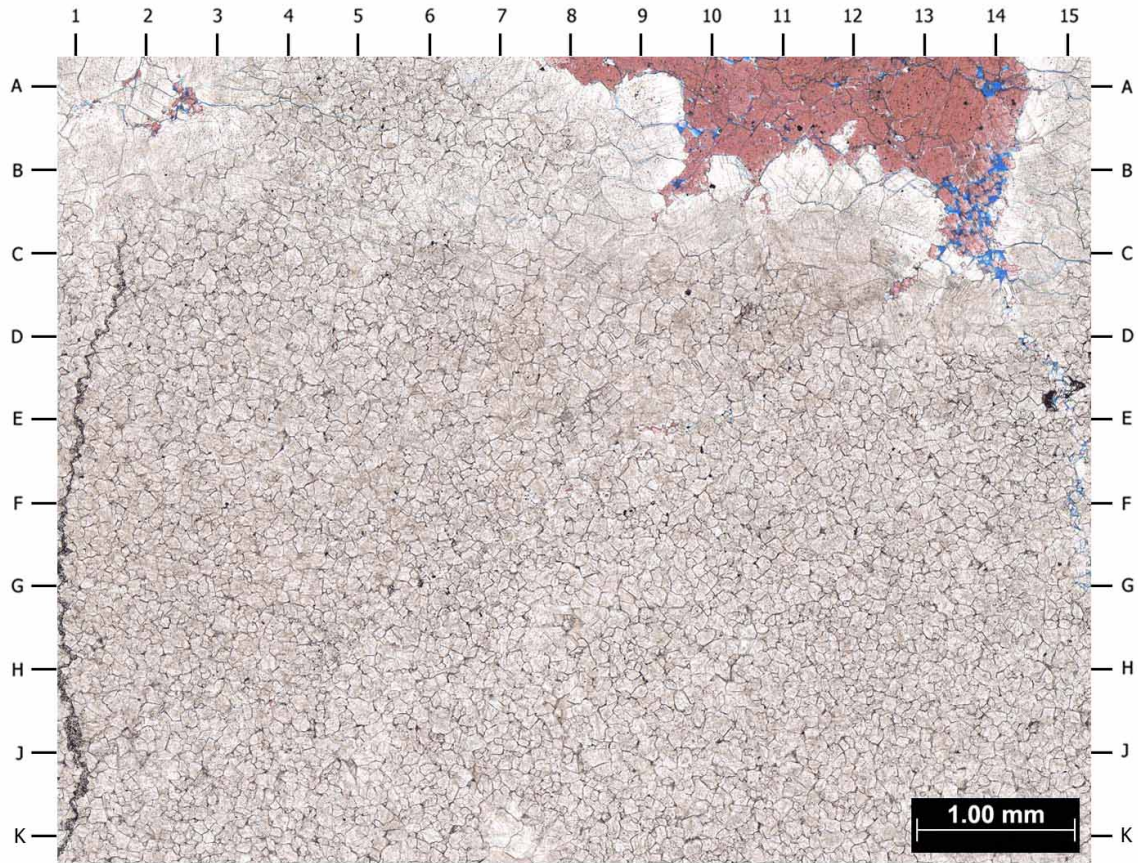
- B) This photomicrograph was taken from the top-right quadrant of Photo A, just below a large vug cemented by sparry calcite cement (stained red; AB10-14). Microcrystalline pyrite occurs along an incipient microstylolite from K1 to C1.7. The process of dolomitization has completely destroyed the original texture within this dolostone.
