**Cabot Oil & Gas Corporation  
Cambrian No. 1 Project  
Gainer Lee  
Wayne County, West Virginia  
Conventional Core Samples**

**Weatherford File No.: HH-77641**

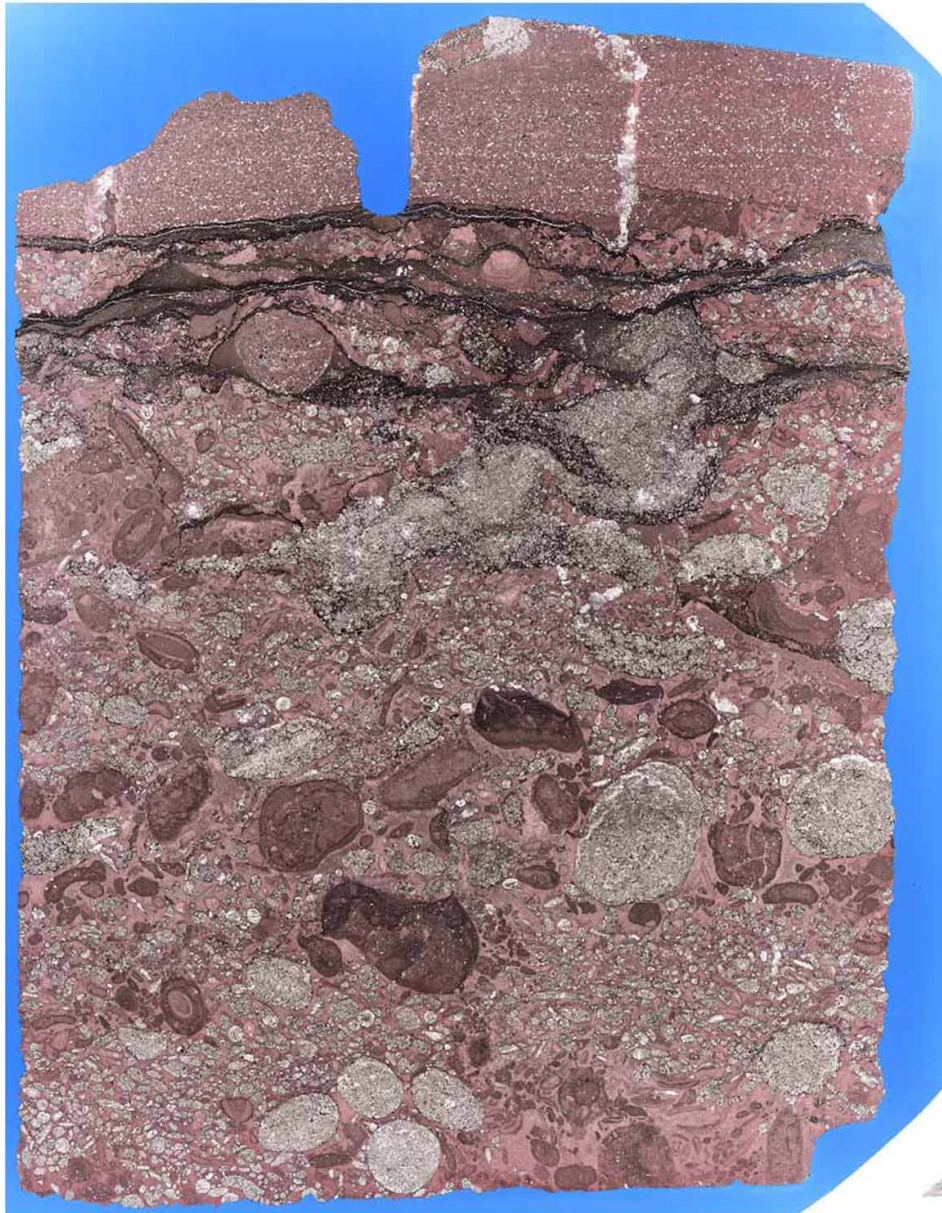
**PLATE 51A**

This static macro photo was captured from the high resolution thin section mosaic image and documents the entire thin section slide.

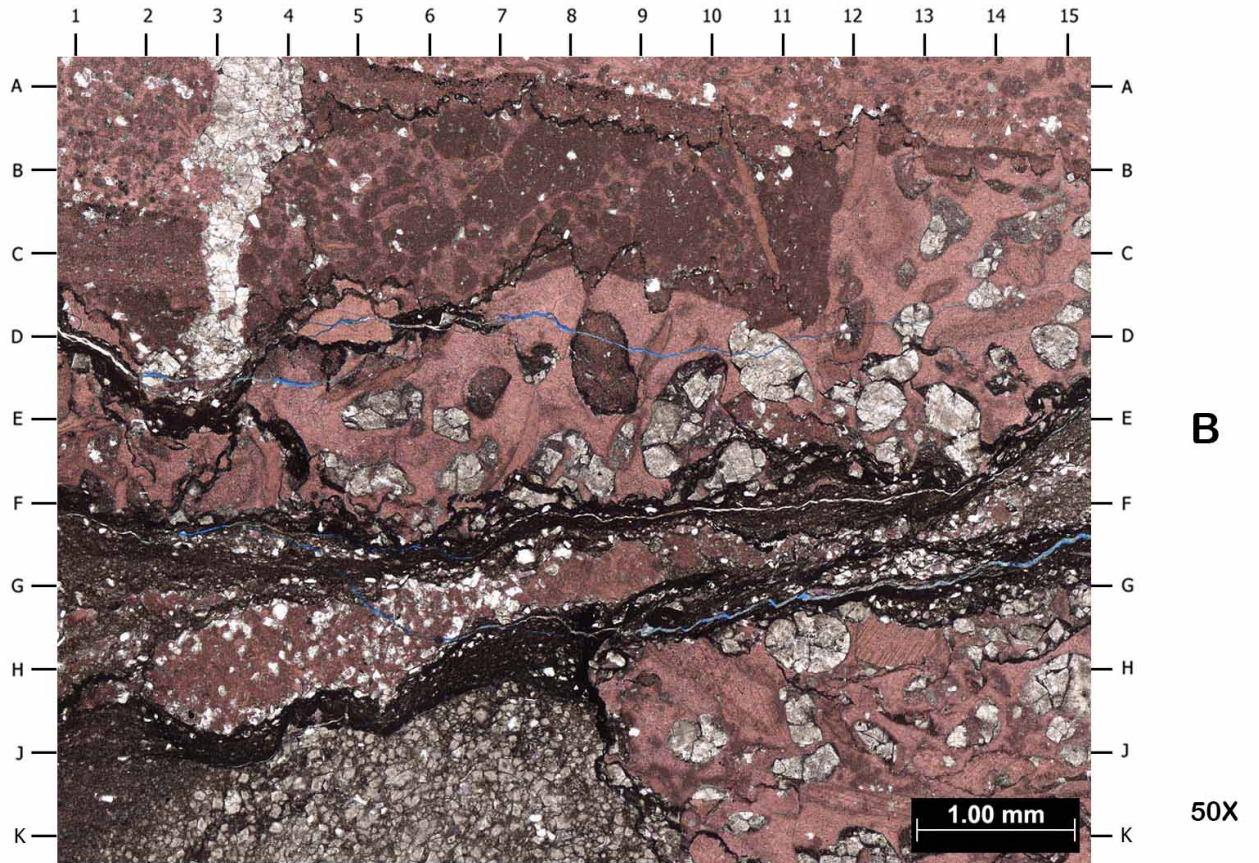
- B) This dolomitic limestone exhibits a grainstone texture. This image was taken from the top-right quadrant of Photo A. Clay and partially pyritized bituminous organic material occur concentrated along stylolites (AB5-12.5, D1-C8, FG1-EG15, JK1-G15) with dolomitization (JK3-9, FG12.5) of the matrix occurring along these pressure-dissolution boundaries. The fabric appears to be locally displaced due to possible micro faulting along a dolomite-cemented vertical fracture (AD3.2).
- C) This photomicrograph provides a high magnification view of the area centered near BC11.6 in Photo B. Grains/allochems visible in this view include micritic peloids (B15, A5, AB8.7, FG2, GH3), potassium feldspar grains (AB1.7, D6, BC10), quartz grains (B6.4), dolomitized intraclasts (GJ14.5, EF13), probable trilobite fragments (DE3.5-JK5.5, FG9.5-BC11), and an echinoderm fragment (GH11.5).

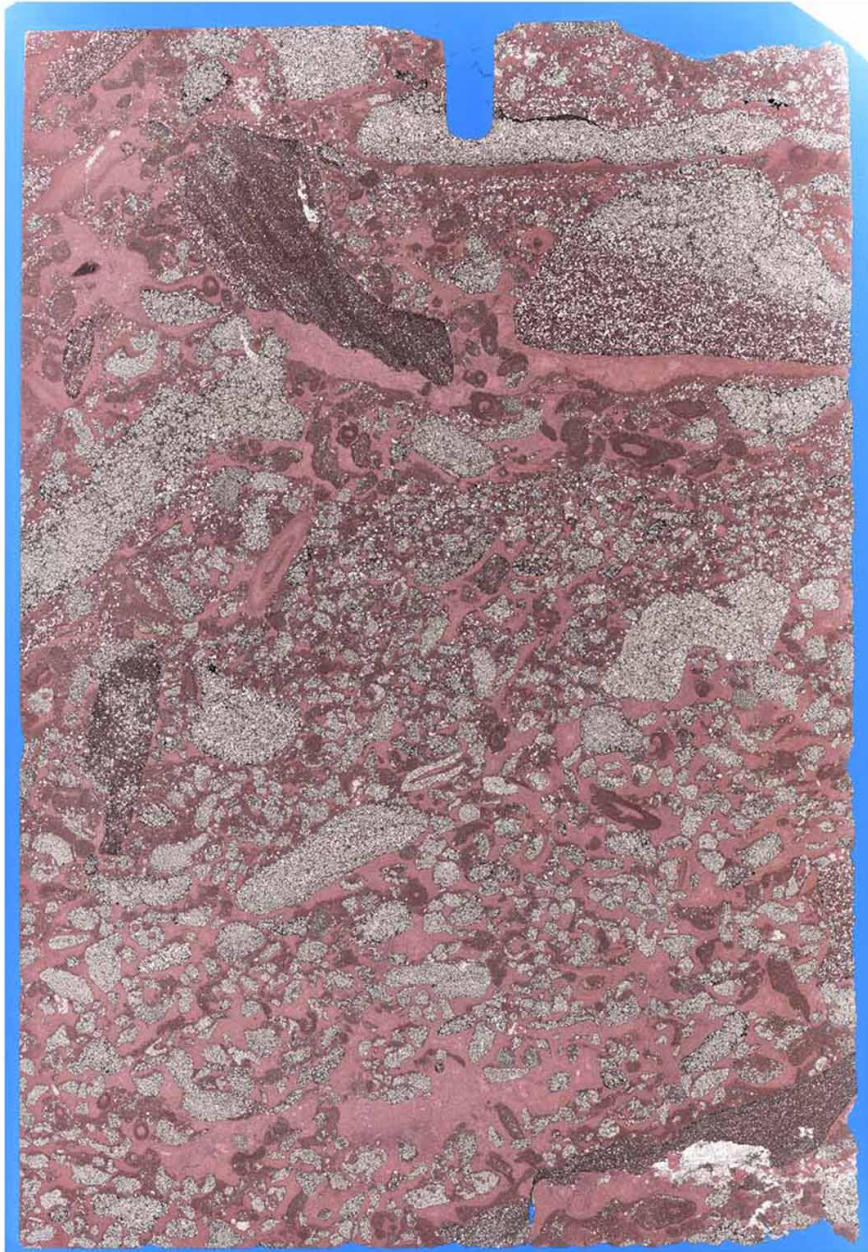
**PLATE 52A**

This static macro photo was captured from the high resolution thin section mosaic image and documents the entire thin section slide.

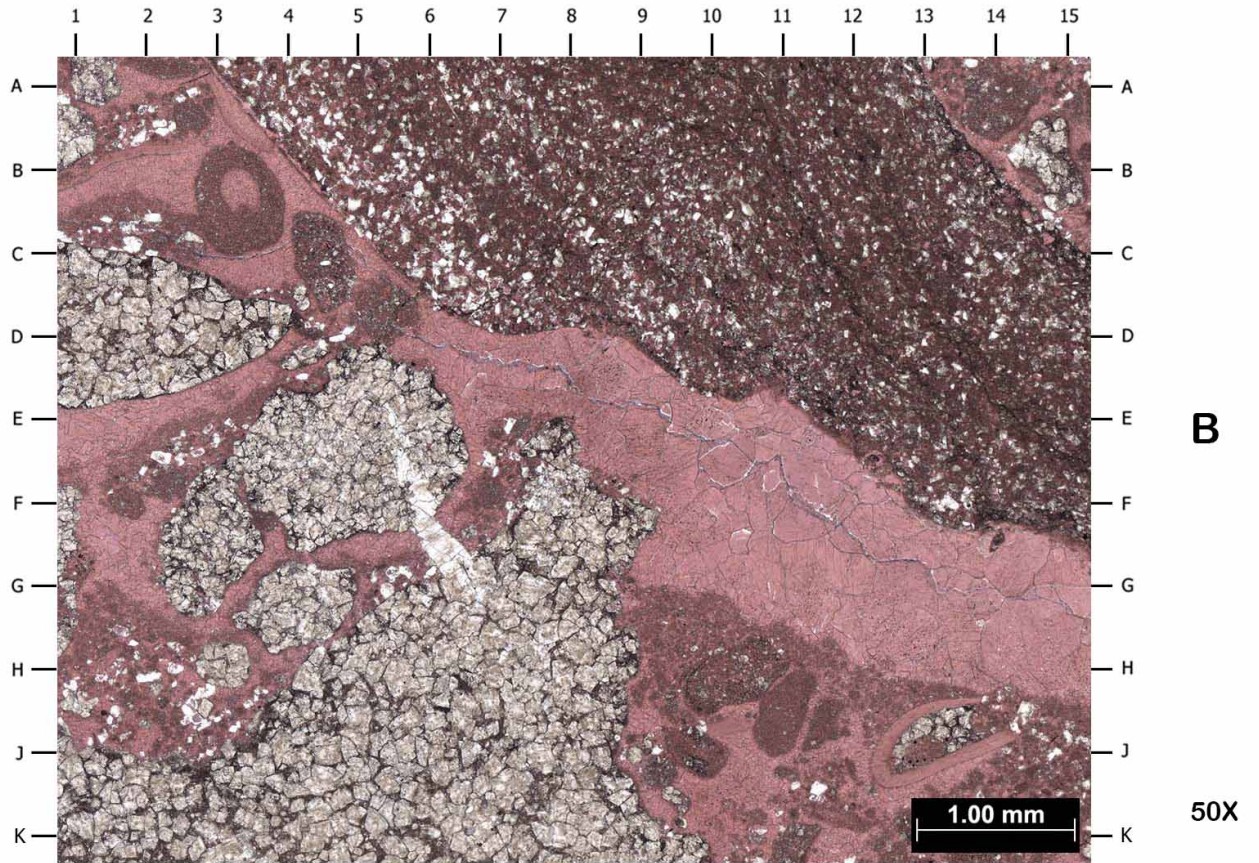
- B) This image was taken from within the top-left quadrant of Photo A. This dolomitic limestone exhibits a massive grainstone texture. Very abundant amounts of sparry calcite cement (stained red; B2, E1-2, FG1.5, DE6-9, G9-15, J10.5) occlude the interparticle spaces between over-sized silty/sandy limestone intraclasts (A4-CF15), dolomitized intraclasts (D1-3.5, EF4.5, GH4, JK1-FK8), and micritic peloids (C4.5, HJ11, AB14).

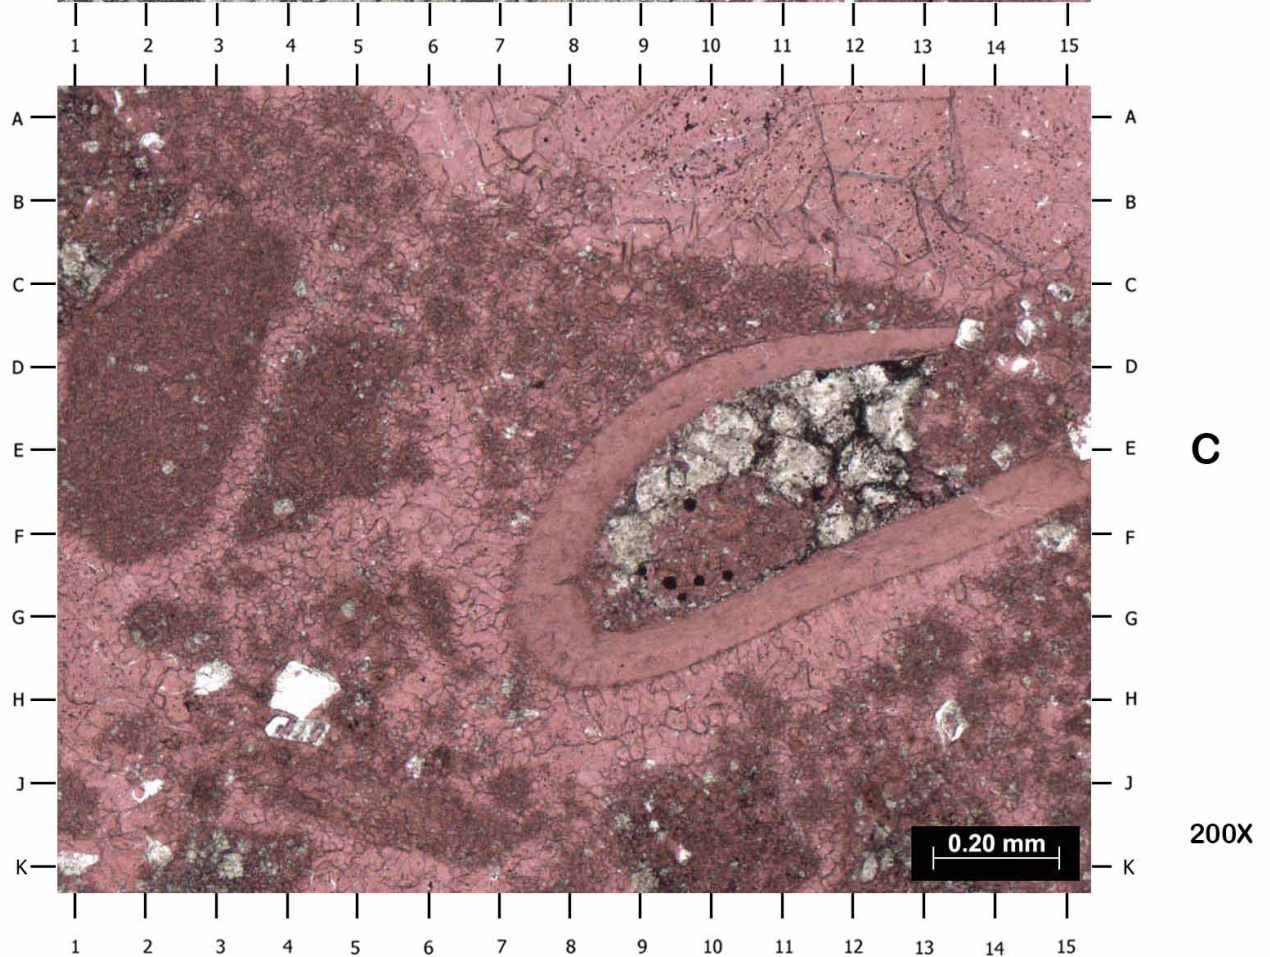
- C) This photomicrograph provides a high magnification view of the area centered near J12.2 in Photo B. Sparry calcite cement occludes open spaces between micritic peloids (G2.5, J7.2, CD6.3, H10.8, DE2.5), feldspar grains (H4.2, HJ13.3, J2, CD14.4), localized patches of partially recrystallized lime mud (CD8-13), and a trilobite fossil fragment (G7.5-EF15). Dolomite cement occurs within the hooked end of the trilobite fragment (E9-12). Crystal size development of the sparry calcite cement appears to be related to the available size of the void space that the cement is filling, with finely crystalline spar occupying smaller voids (H8.5, G1.5, G6.5, FG6, K5) and coarsely crystalline spar filling larger voids (AB6-15).

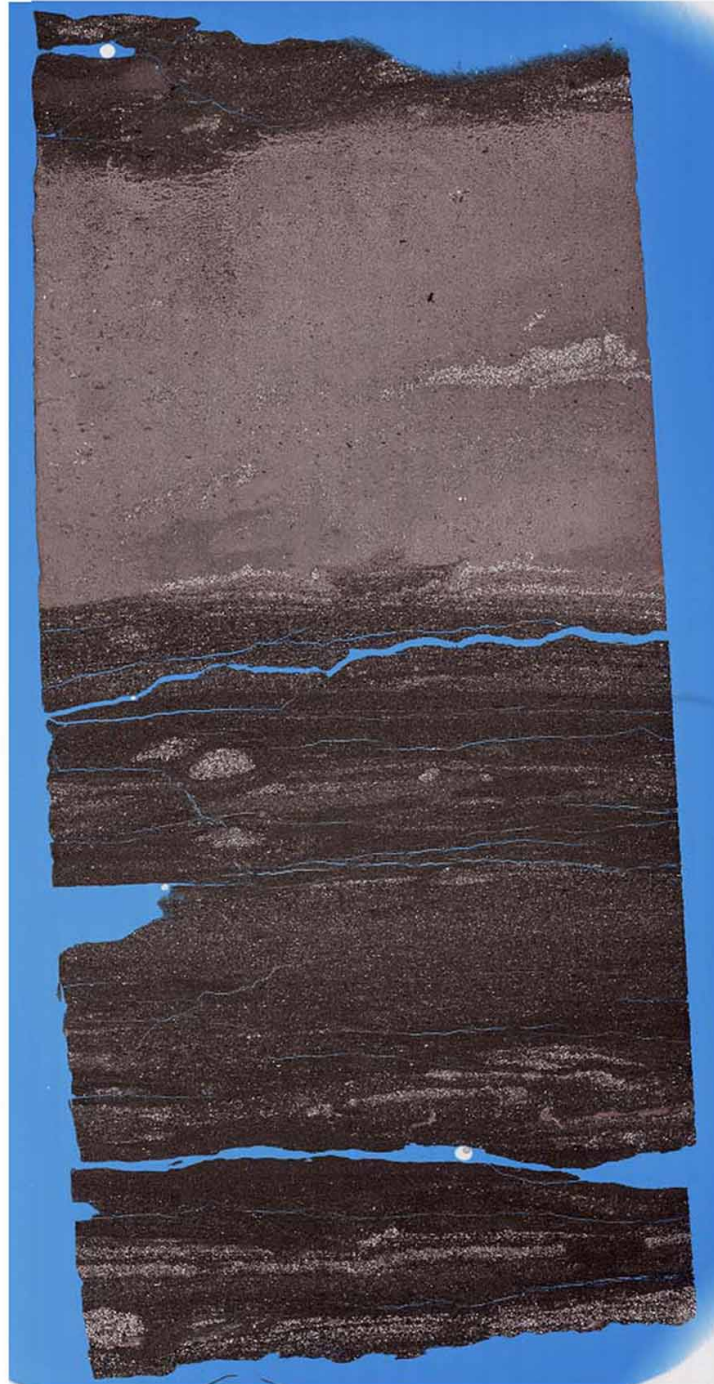
This static macro photo was captured from the high resolution thin section mosaic image and documents the entire thin section slide.

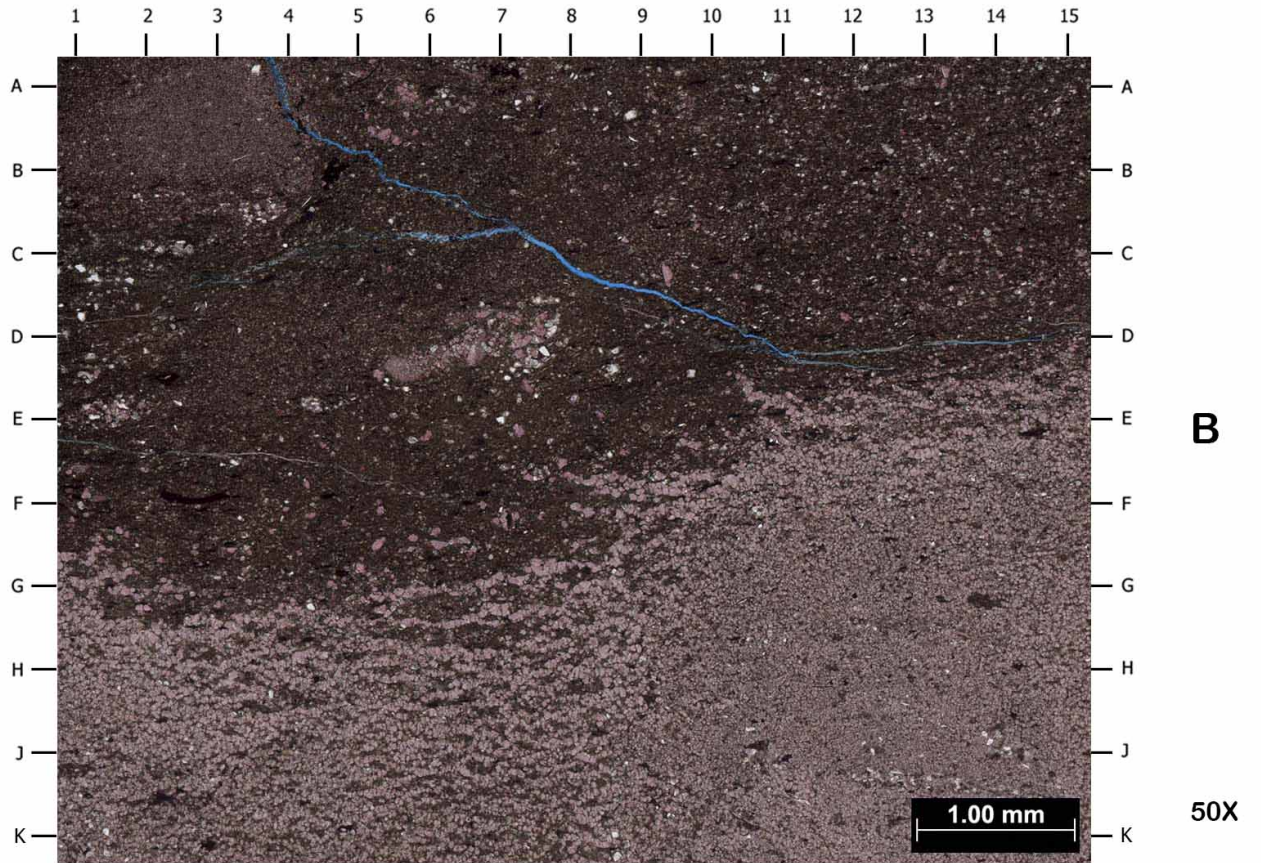
- B) This image was taken near the top-left corner of the macro Photo A and illustrates the contact between the silty calcareous mudstone lithology (AF1-AD15) and the slightly argillaceous limestone lithology (HK1-EK15). Patches of partially recrystallized micrite occur within the mudstone portion at AB2-4 and DE3-5. The general texture of this sample is burrowed and slightly laminated. Microfractures filled with blue-dyed epoxy were artificially induced during sample preparation.

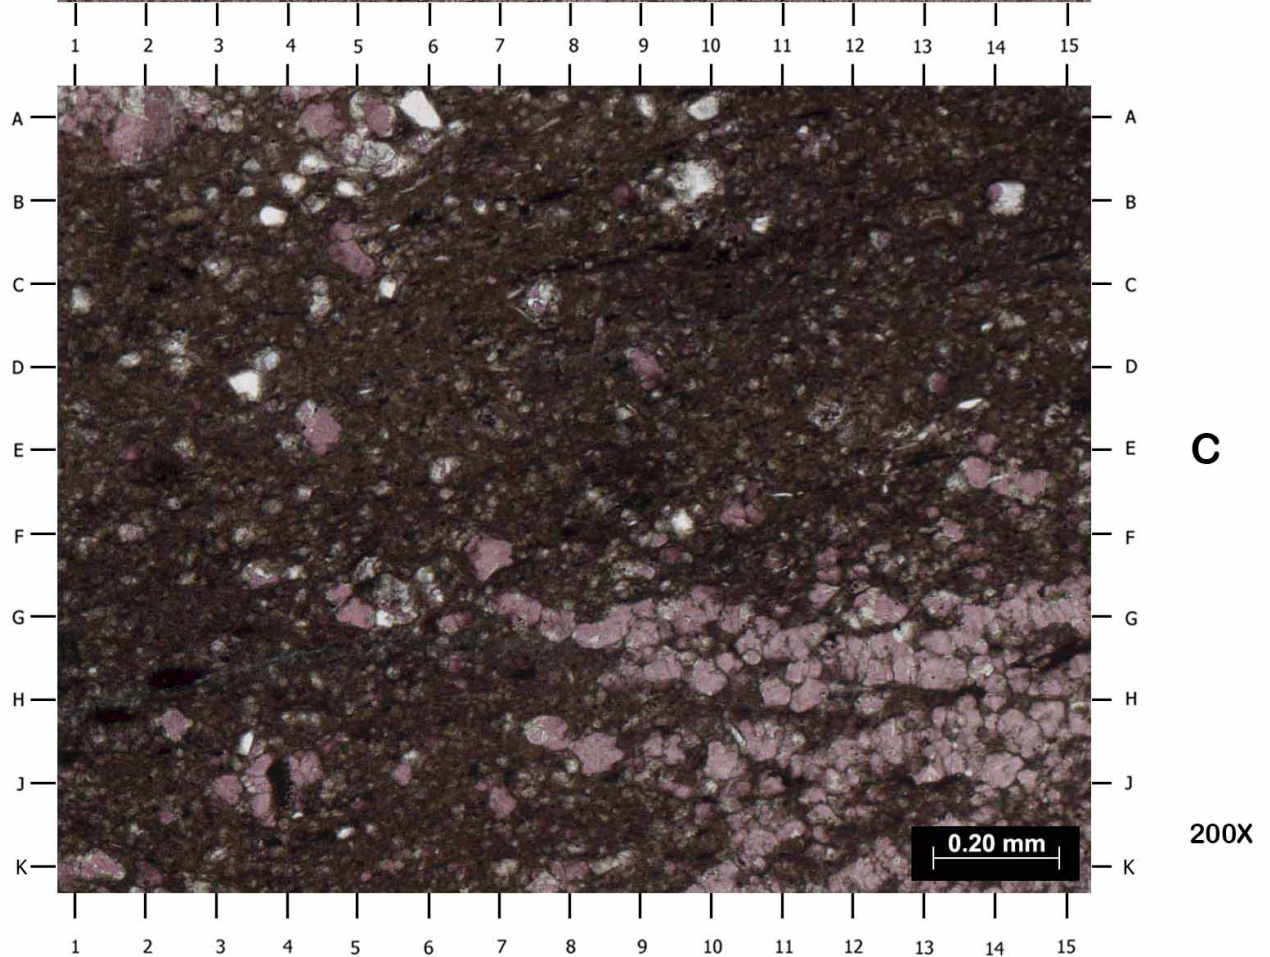
- C) This photomicrograph provides a high magnification view of the area centered near EF8 in Photo B. Grains/allochems visible in this view include silt-sized quartz grains (A6, DE3.3, BC3.7, EF9.6), mica (EF11, HJ10.3), and organic fragments (GH2.3, HJ1.3, J3.8, BC5.9). Calcite replaces unstable grains (C7.5, B14, FG12.3, K1.3). The transitional region between the mudstone to limestone consists of high concentrations of fine calcite crystals (stained red) with detrital clay matrix filling the intercrystalline spaces (GK9-15). Minor scattered dolomite crystals replace unstable grains and small particles within the matrix (DE11.5, F1.9, D2.3, CD14).

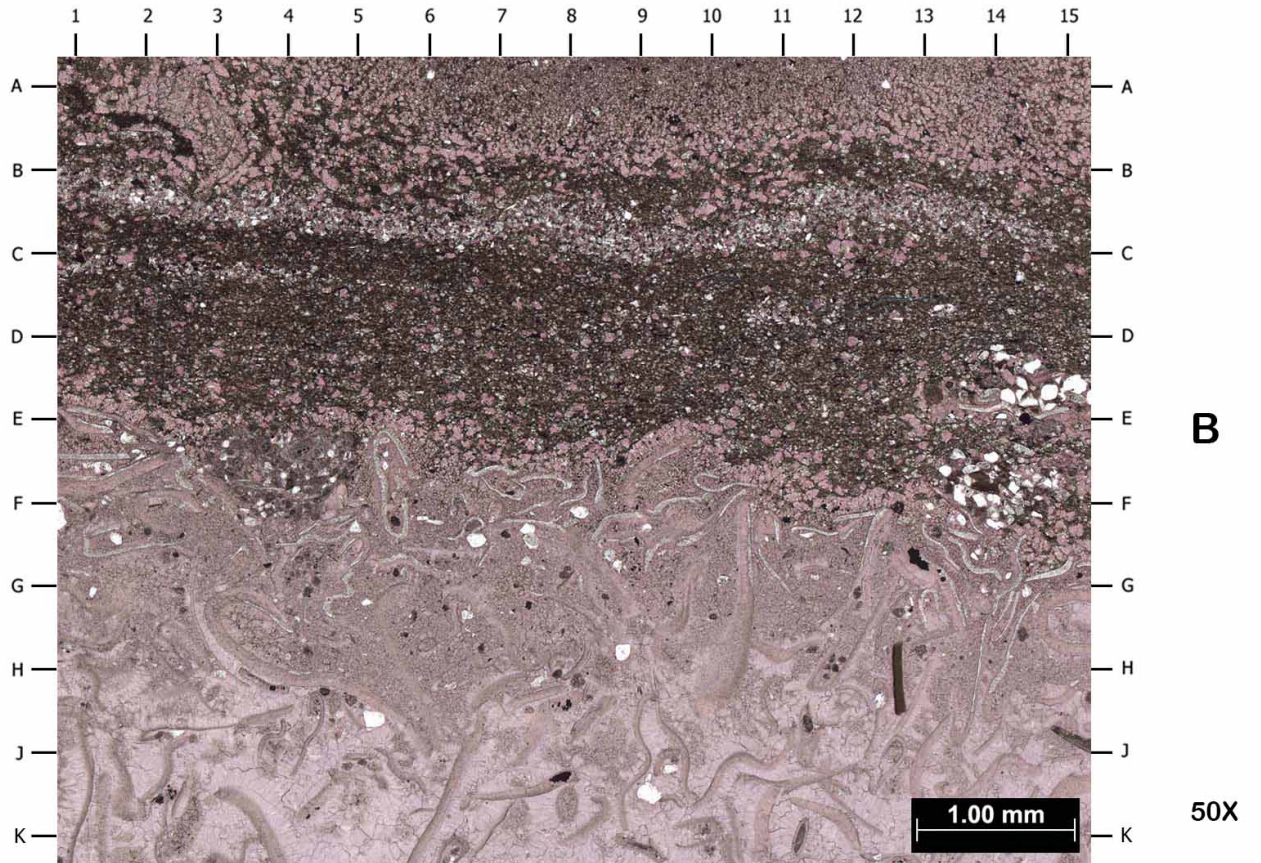
B) This photo illustrates the following three lithologies represented within this sample: dominant fossiliferous limestone (EK1-GK15); slightly calcareous, silty mudstone (BD1-15), and slightly argillaceous limestone (AB1-15). Abundant amounts of sparry calcite cement (K4.5, JK1) occlude interparticle spaces between trilobite fragments (JK6, GH3.5, J10) within the dominant limestone lithology. Probable silt/sand-filled burrows are pictured at DE14.5 and F14.

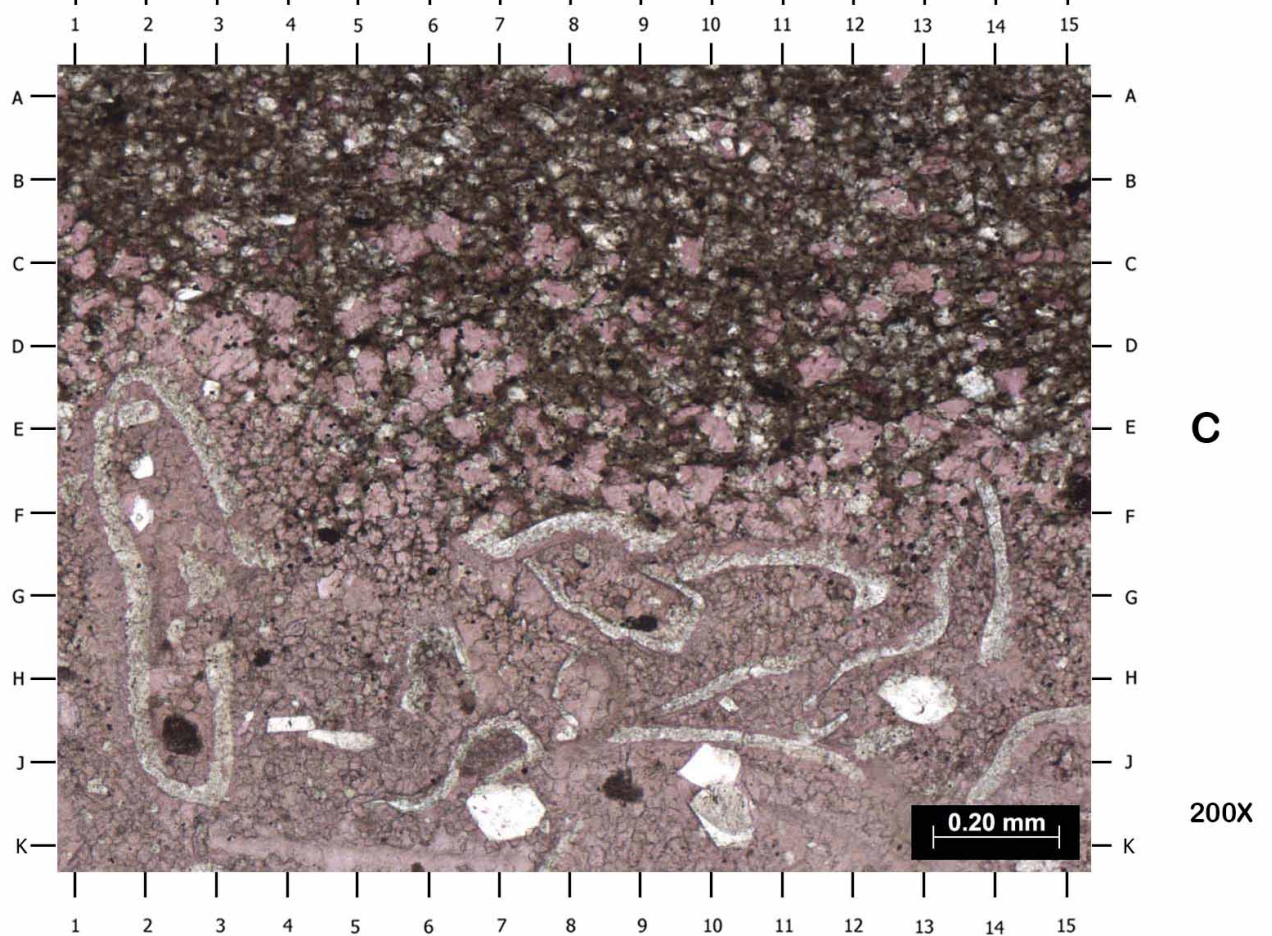
C) This photomicrograph provides a high magnification view of the area centered near EF7 in Photo B and documents trilobite fragments replaced by dolomite/quartz (EJ2, FG14) only along the transitional boundary between limestone (stained red) and slightly calcareous, silty mudstone (AB1-AD15). Quartz (J10), feldspar (JK10.3, HJ4), and organic particles (DE11, B15) are also pictured within this view.
