**Cambrian No. 1 Project
McCoy
Wayne County, West Virginia
Conventional Core Samples**

Weatherford File No.: HH-77641

Cabot Oil & Gas Corporation
Cambrian No. 1
McCoy Well
Wayne County, West Virginia

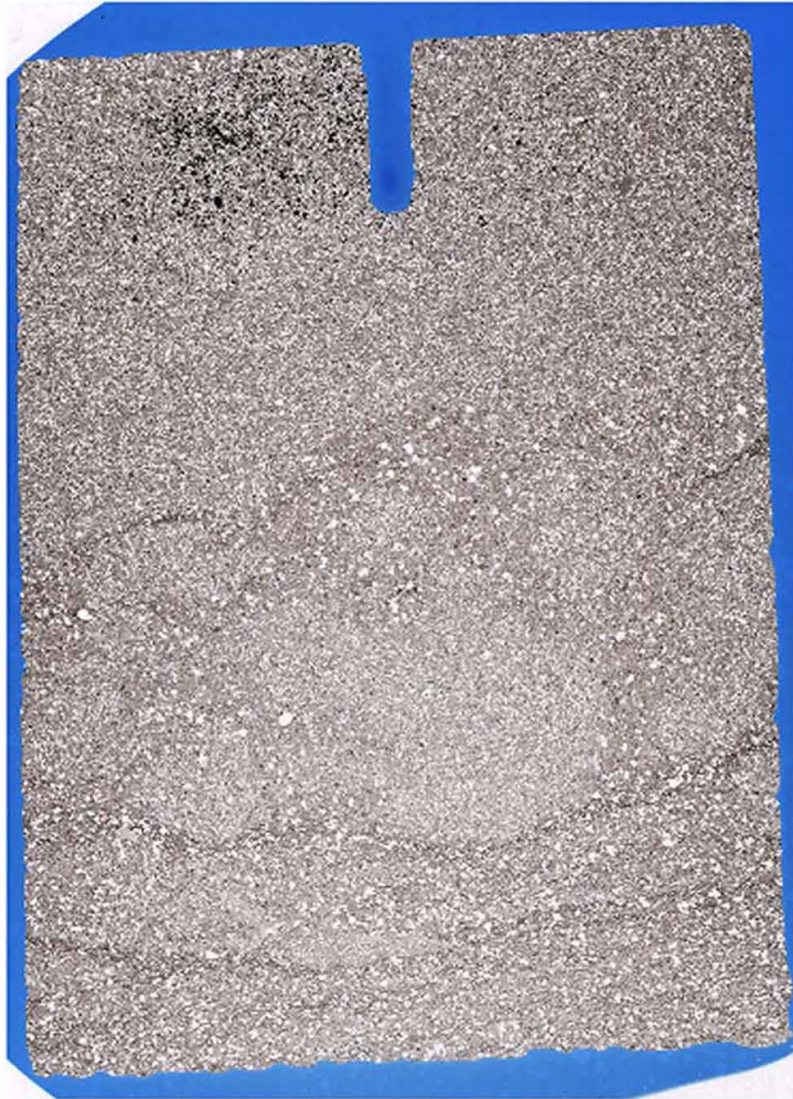
14092.00'
Plate 7

T.O.C.: 0.01% (weight percent)

This static macro photo was captured from the high resolution thin section mosaic image and documents the entire thin section slide.

Magnification: A: 1X

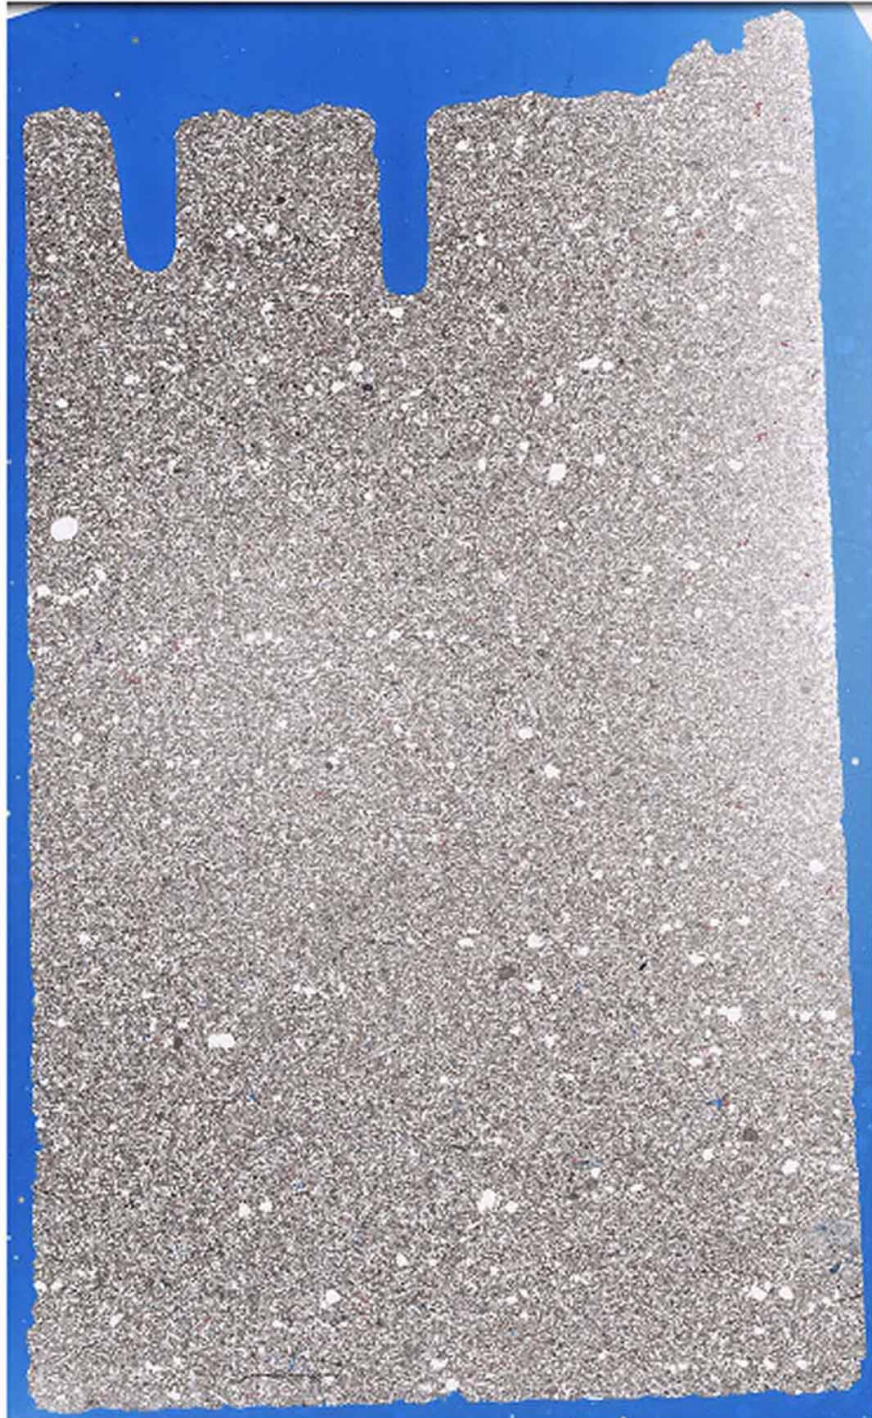
A

This static macro photo was captured from the high resolution thin section mosaic image and documents the entire thin section slide.

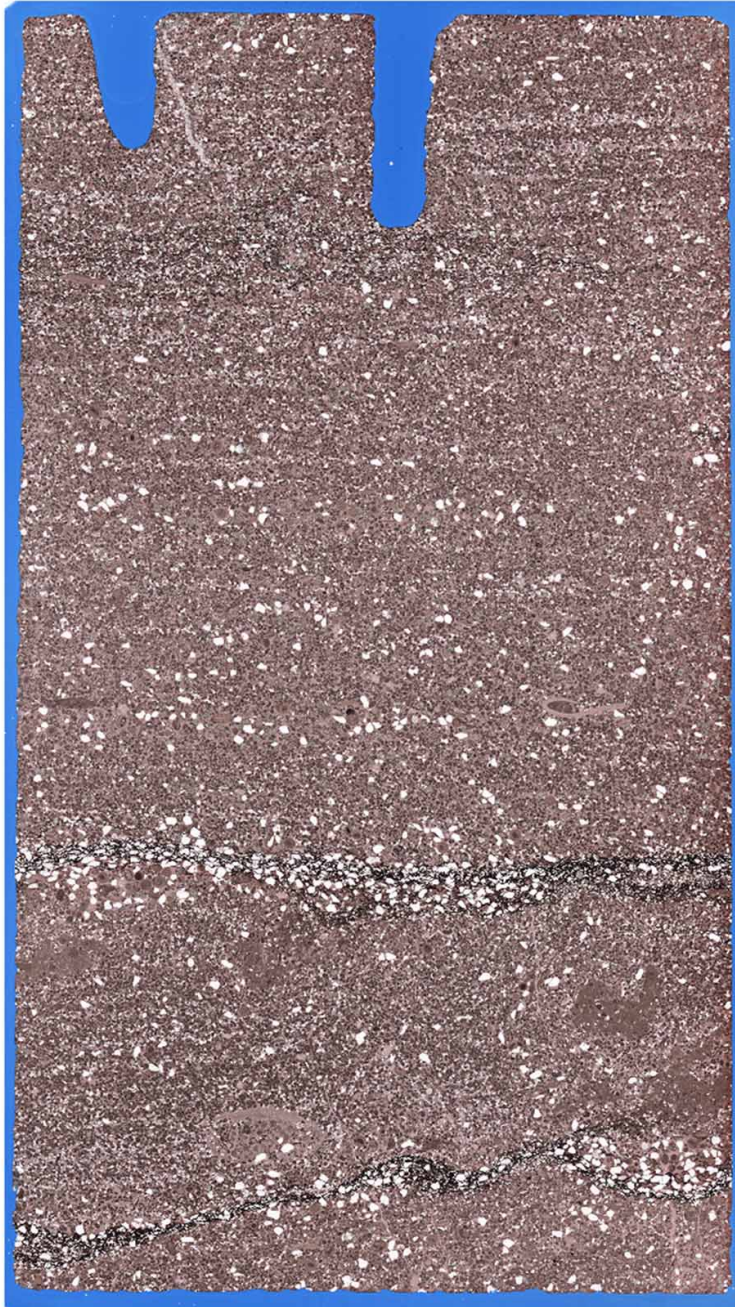
This static macro photo was captured from the high resolution thin section mosaic image and documents the entire thin section slide.

Magnification: A: 1X

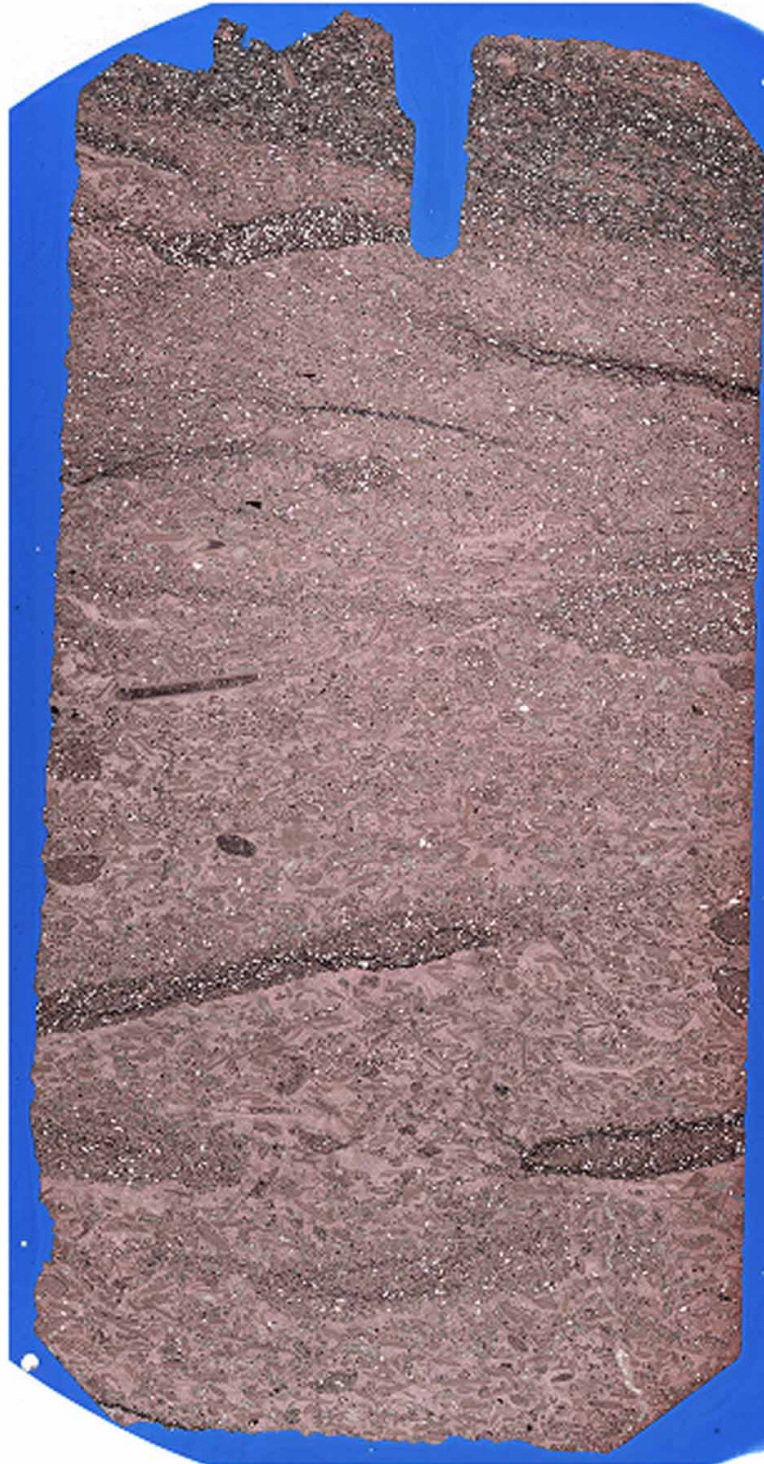
This static macro photo was captured from the high resolution thin section mosaic image and documents the entire thin section slide.

Magnification: A: 1X

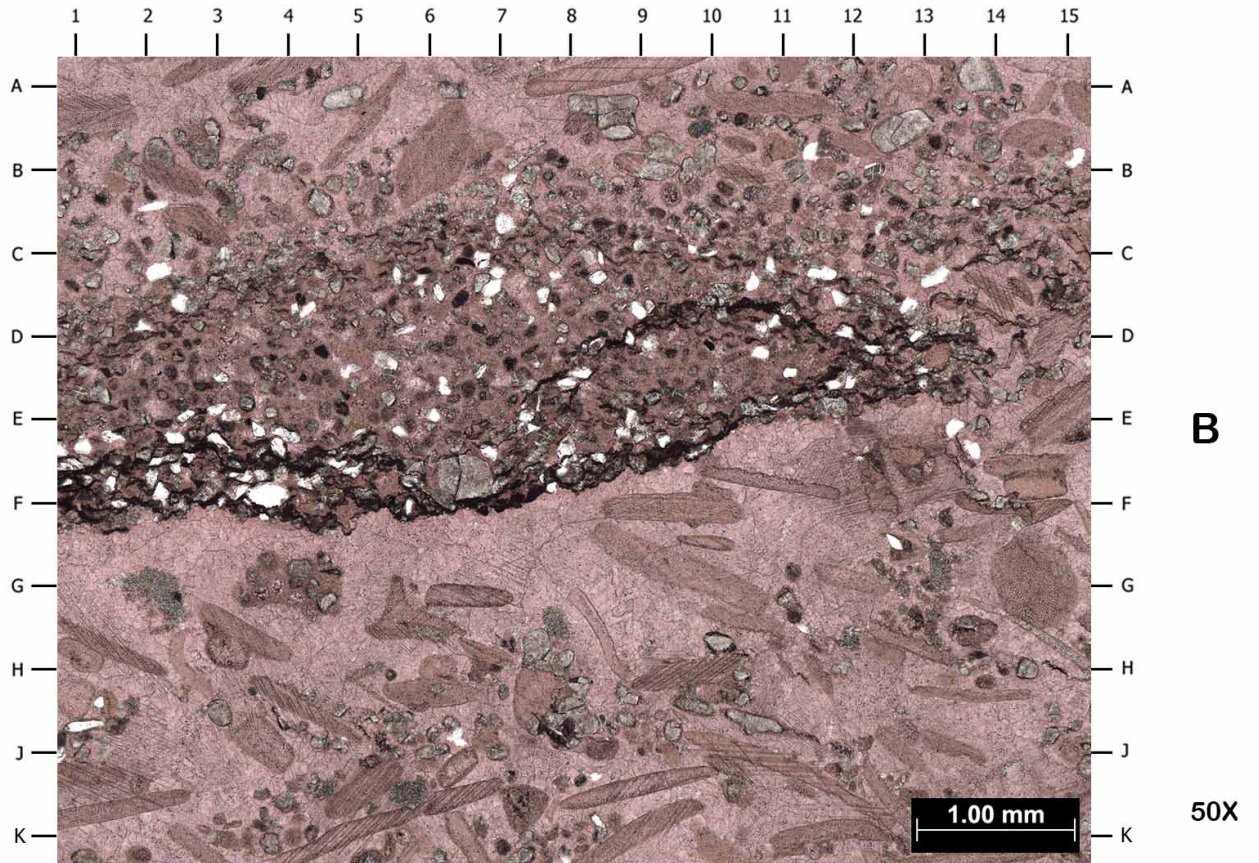
- B) This image was taken approximately 0.5cm below the center of the thin section. This limestone contains common to abundant echinoderm fragments (AB1.3, JK1-2, G14.5, EF14.5, JK9). Echinoderm fragments exhibit unit crystal extinction under cross-polarized light and are often associated with syntaxial overgrowth sparry calcite cement around their perimeters. An organic-rich microstylolite occurs at EF1 to DE13 in association with a localized concentration of micritic peloids (DE2.5, CD8.5) as well as very fine sand grains of feldspar/quartz (white; BC2, BC7, CD13).

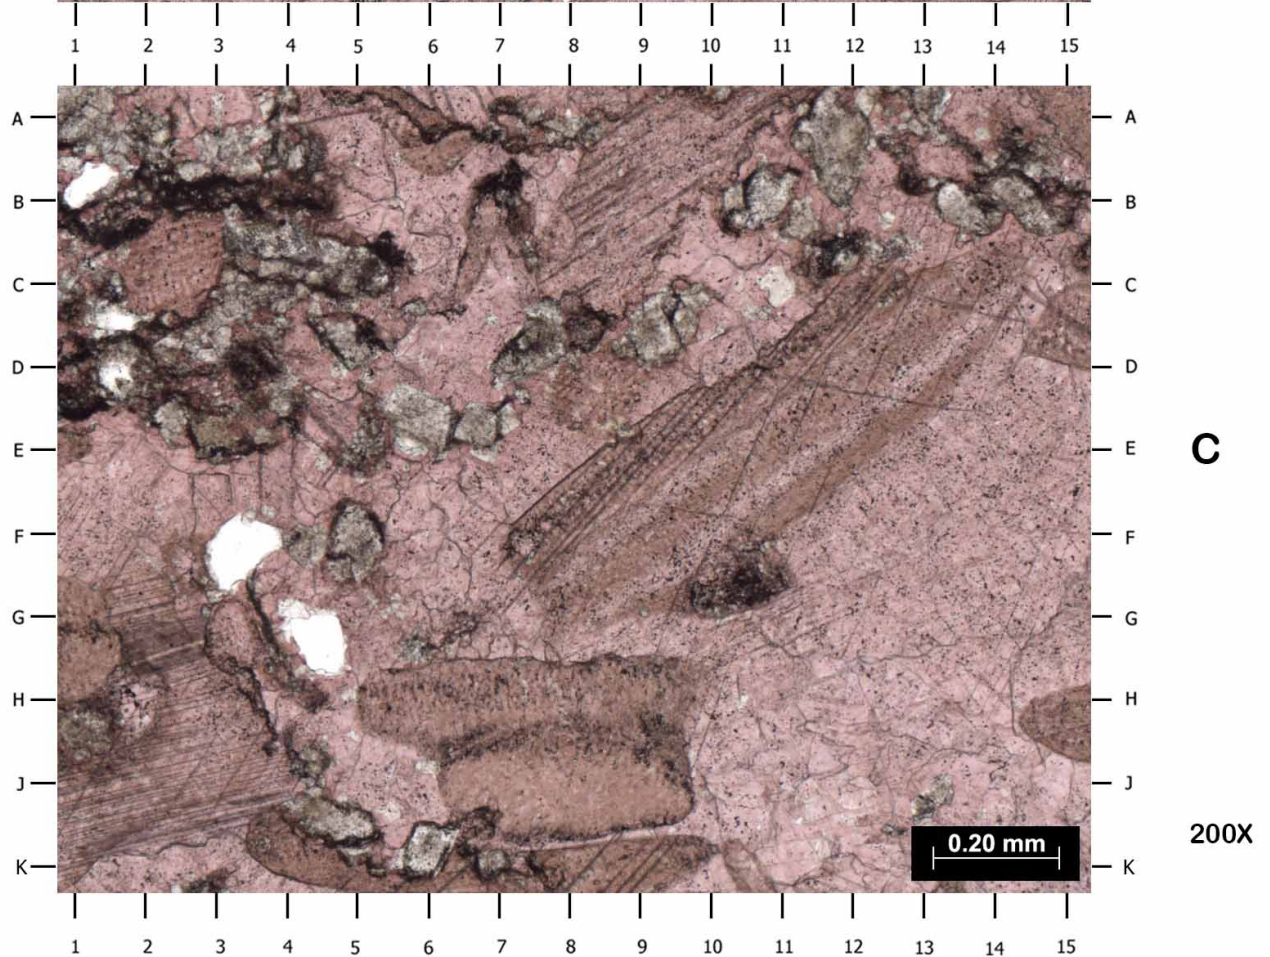
- C) This photomicrograph provides a high magnification view of the area centered near E14.5 in Photo B. Sparry calcite cement occludes the interparticle spaces between echinoderm fragments (HJ8, JK4-10, F7.5-C14, B9, C2.2), quartz/feldspar grains (B1.2, FG3, GH4.5), and dolomite-replaced grains/allochems (BC4, B11, B14.3, AB11.8, F5). A microstylolite occurs from CE1 to B15.
