Differential cementation  
in the Tuscarora Sandstone

API# 4703902751

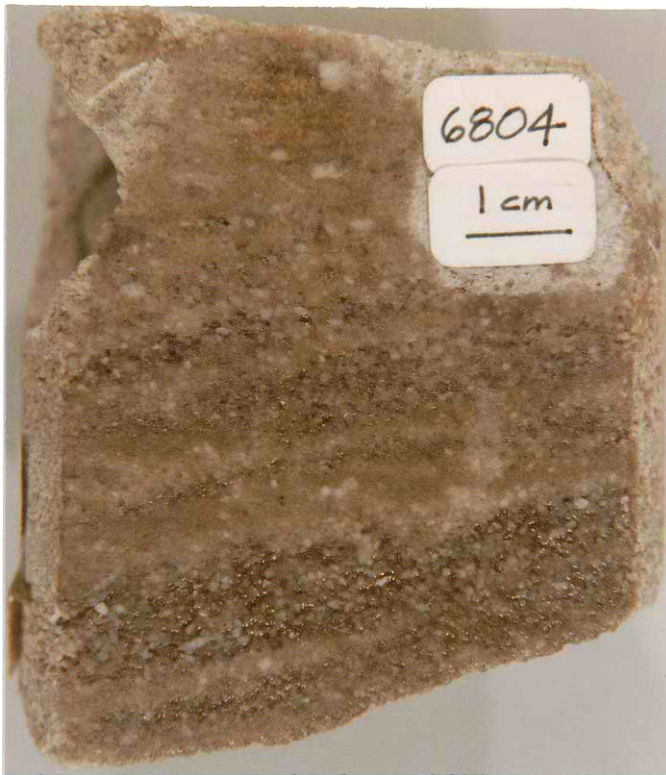
FIG. 25a— Tightly-cemented  
layers alternating with  
poorly-cemented layers.  
Depth in feet.

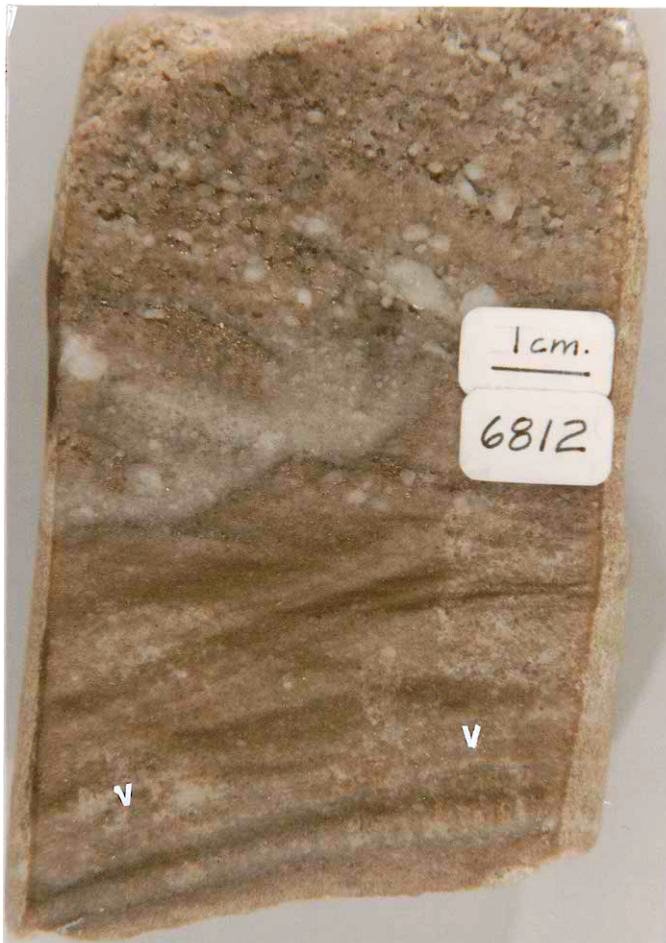
FIG. 25b— Narrow hori-  
zontal and vertical bands  
of tightly-cemented  
sandstone forming a  
lattice pattern (arrows).  
Depth in feet.

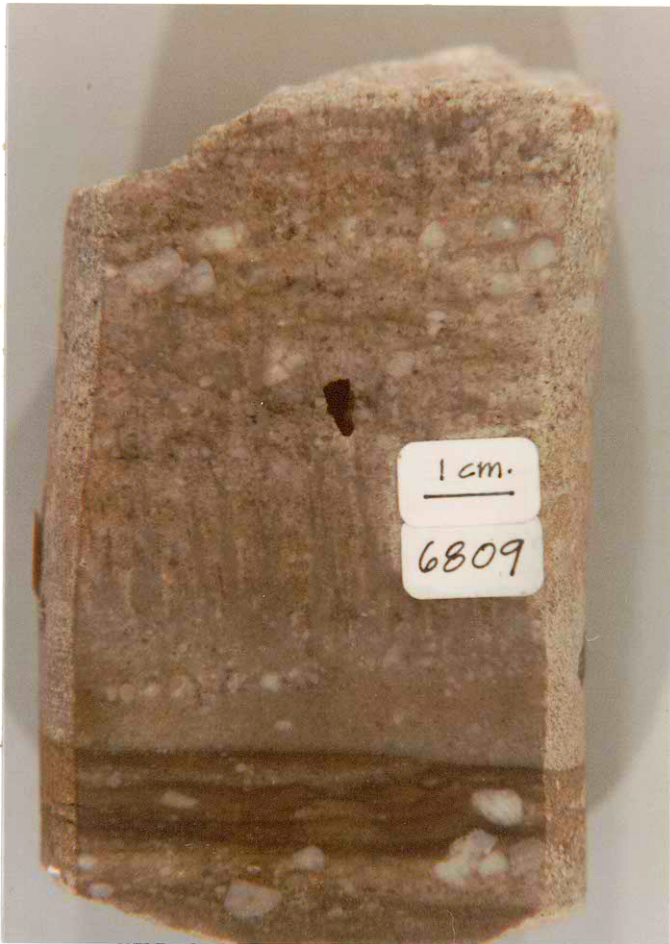
FIG. 25c— Irregular lower digitate boundary, similar to the lower boundaries in poorly cemented disk-shaped lenses found in outcrop. Depth in feet.

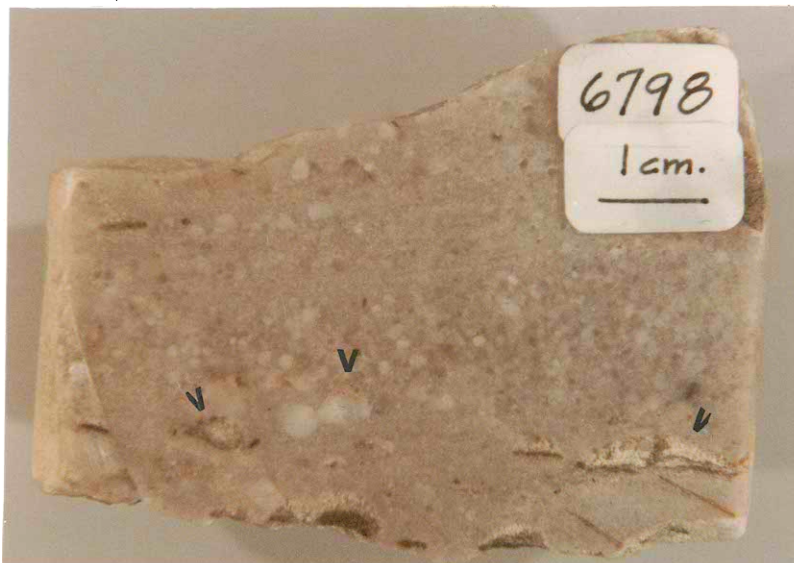
FIG. 25d— Poorly-cemented patches over pebbles and clay clasts (arrows). Depth in feet.
